TRI-STATE ENGINEERING, P.C.
HOME INSPECTION PROFESSIONALS

Report No. 11-1225

INSPECTION REPORT
Of
1300 ALBANY POST ROAD
CROTON-ON-HUDSON NEW YORK
For
VILLAGE OF CROTON-ON-HUDSON

Date: September 21, 2011

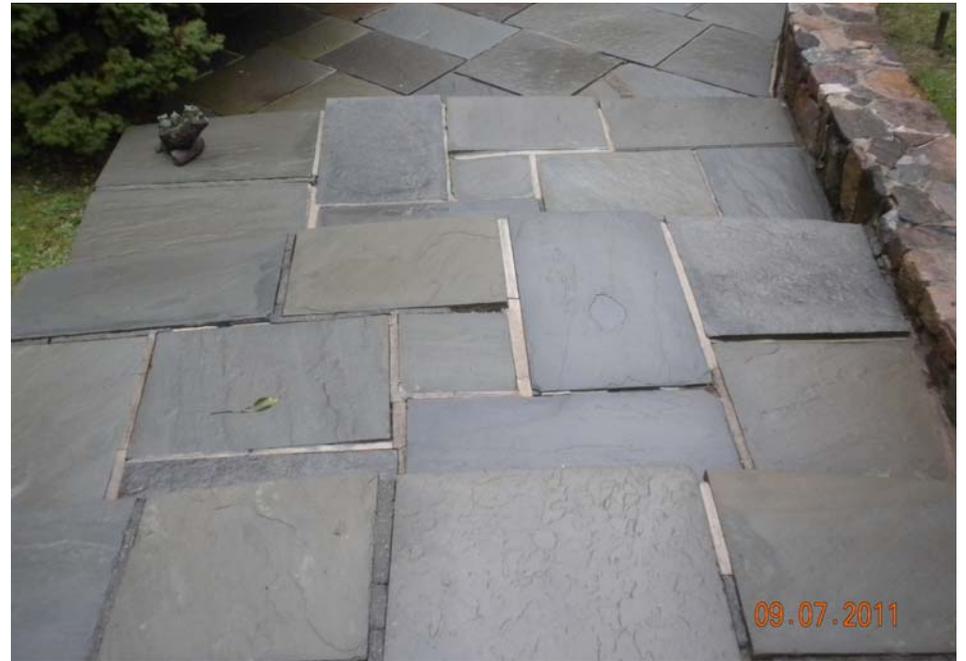
Reset uneven flags at entry walk

4. Re-setting uneven flagstones at the entry walk steps is recommended.
5. Pointing maintenance is recommended at the flagstone entry walk and patio.
6. Trees at the perimeter of the home are overhanging the roof. Removal or cutting back limbs is recommended.

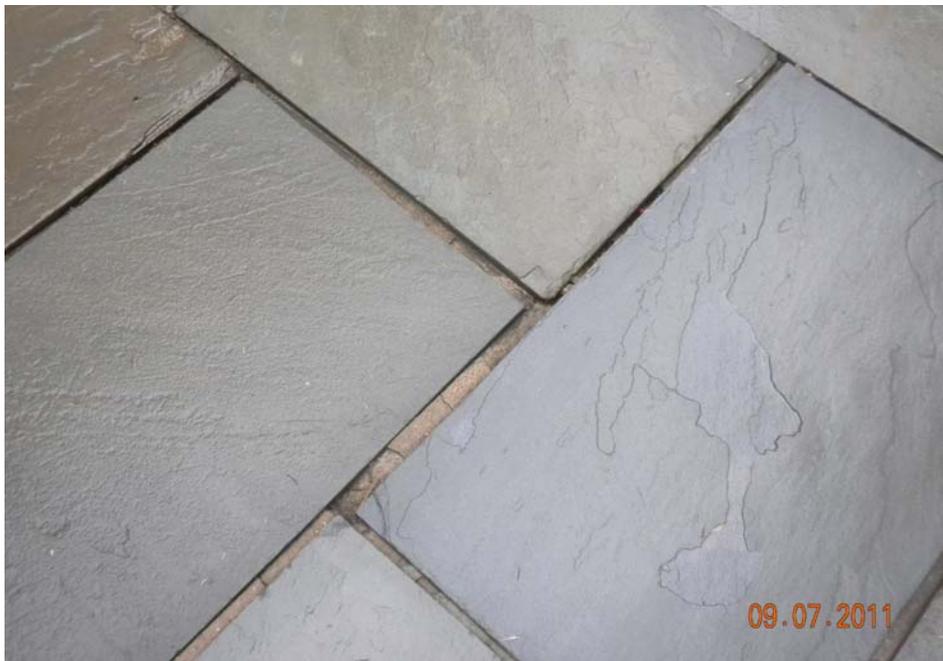
The flagstone patio installed at the south side of the Main House is generally in good condition. Pointing maintenance is required.

Pointing maintenance is recommended at walk and patio of main house

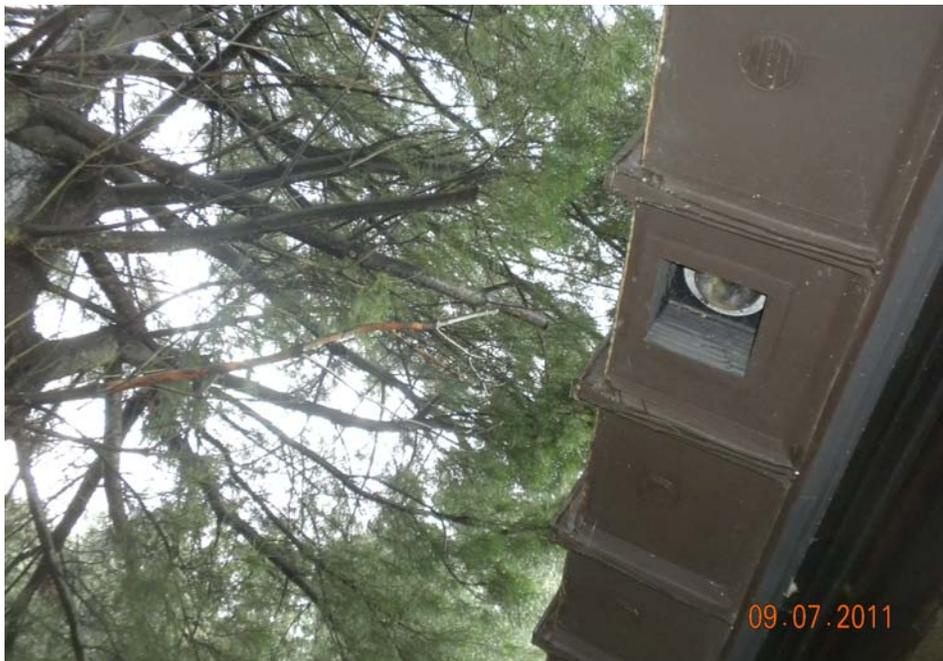
Trim back tree limbs overhanging main house roof

Keep tree branches trimmed back off roof line. Any existing dead trees or branches should be removed. Annual inspection of trees is recommended. The services of a tree specialist are recommended.

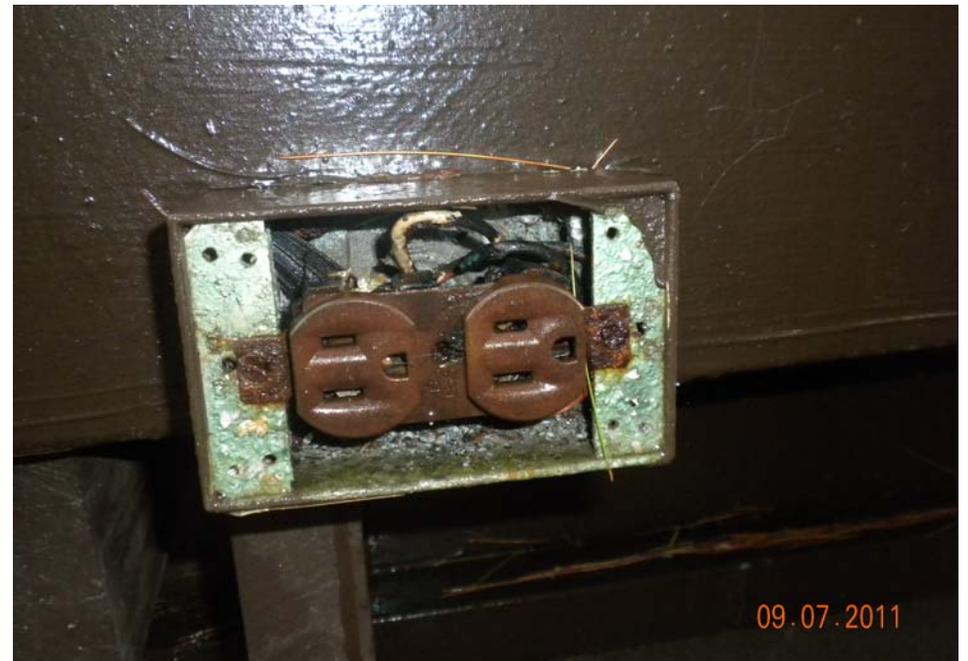
replace exterior outlets with GFCI weatherproof type

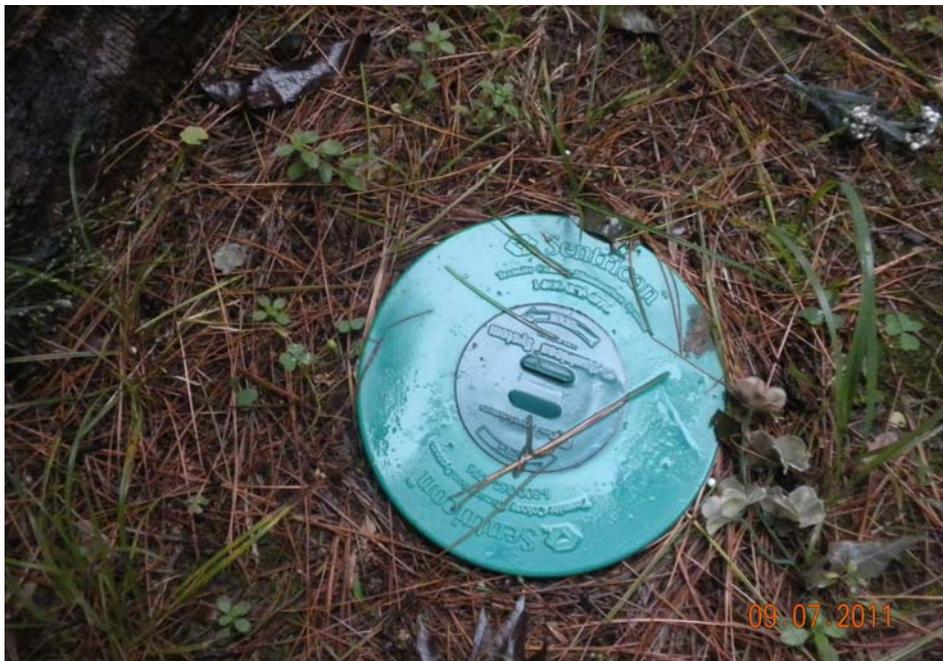
Termite treatment at perimeter of main house

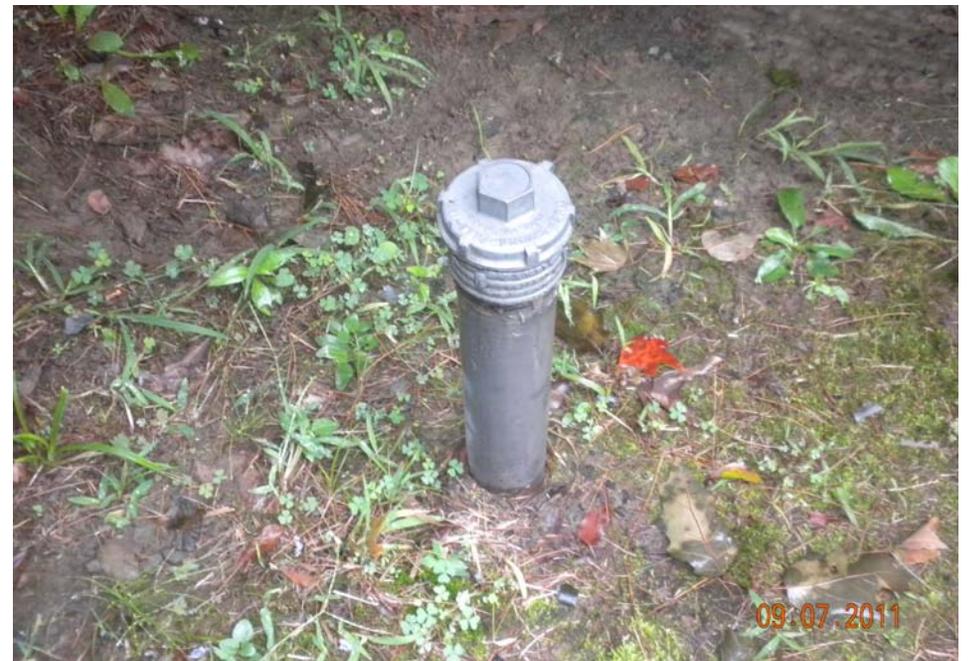
1. A 1,000 gallon underground oil storage tank is located at the north side of the house for the oil fired heating system. The tank is reported to have failed a tightness test. Tank must be addressed in accordance with the requirements of the NYSDEC and Westchester County Department of Health prior to closing.

Oil tank fill pipe at the north side of main house

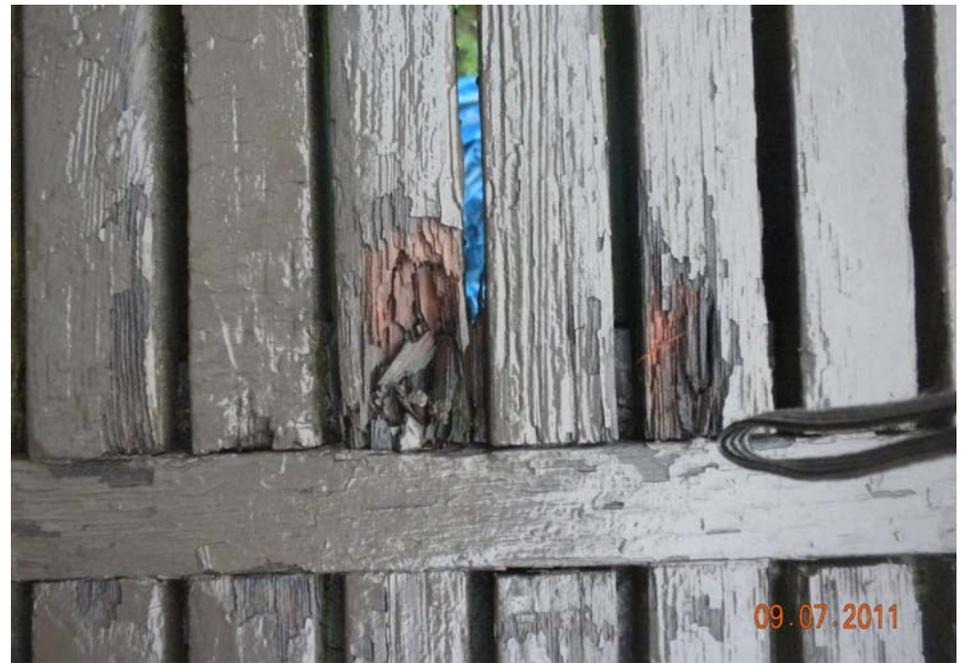
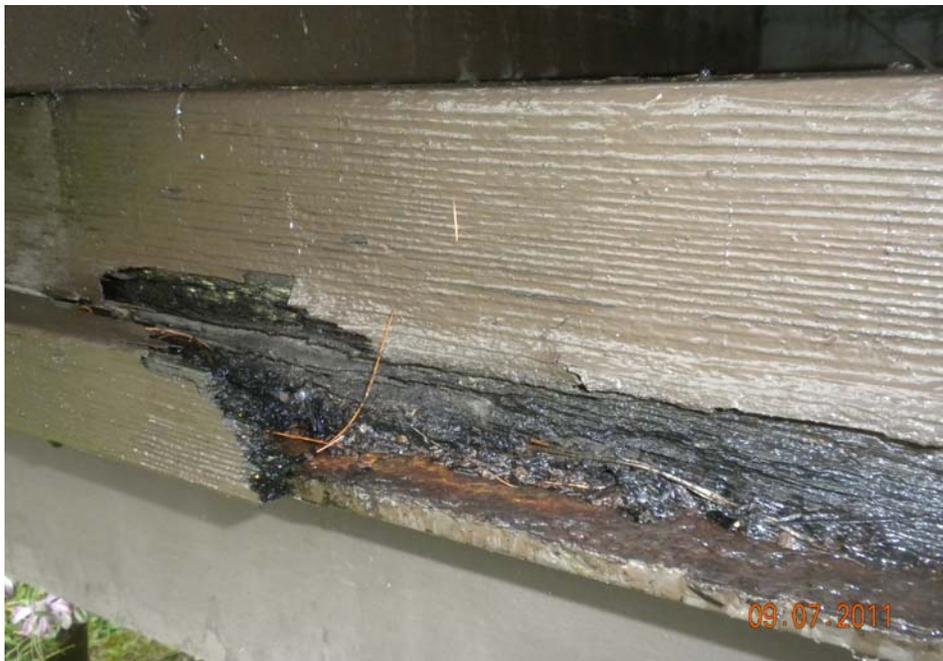
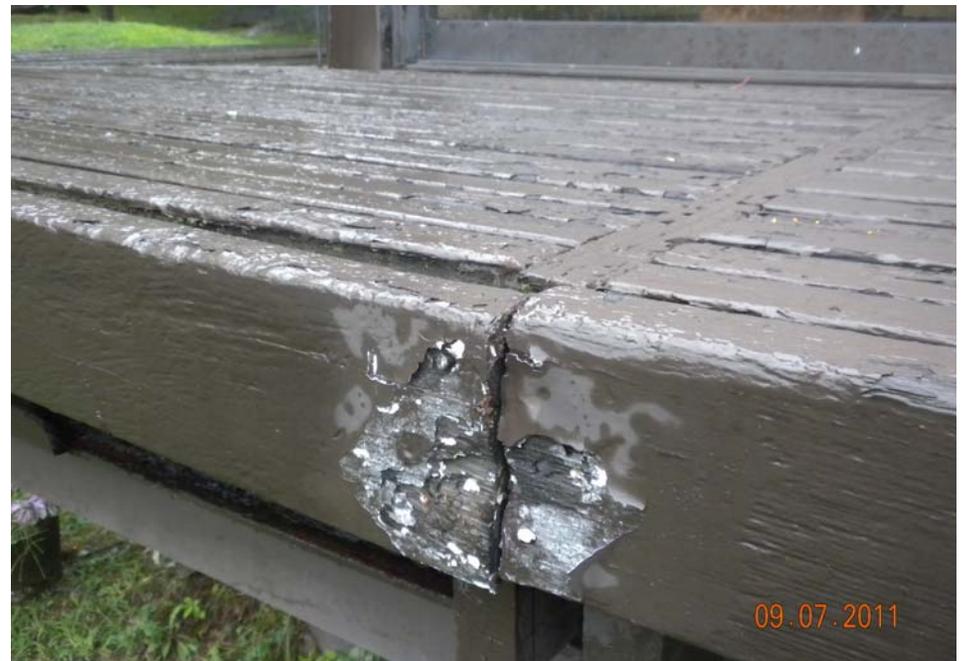
A wood deck/walkway has been installed at the perimeter of the home. Deck is wood framed supported by steel girders. Sections of the decking, joists, sills of the deck are rotted. Replacement of the entire deck is recommended due to noted rot and safety issues. Installation of a railing will be required during up-date.

Wood rot at perimeter deck of main house

3. Sections of the deck at the perimeter of the home are rotted. Wood is not pressure treated type. Deck is installed without safety railings. Replacement of entire deck is recommended due to rot and safety issues. Installation of a railing will be required during up-date.

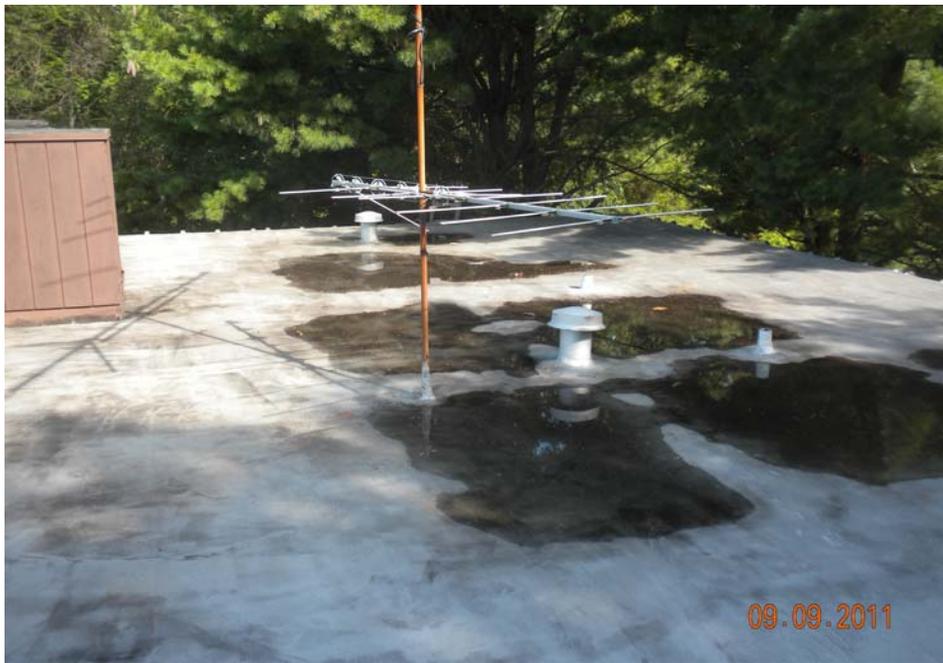
Roofing at the Main House is built-up type and in fair condition. Re-coating roofing with an aluminized paint is recommended at this time. Ponding was noted at low lying areas of the roof. Roofing material is at the end of its useful life.

Ponding water on roof

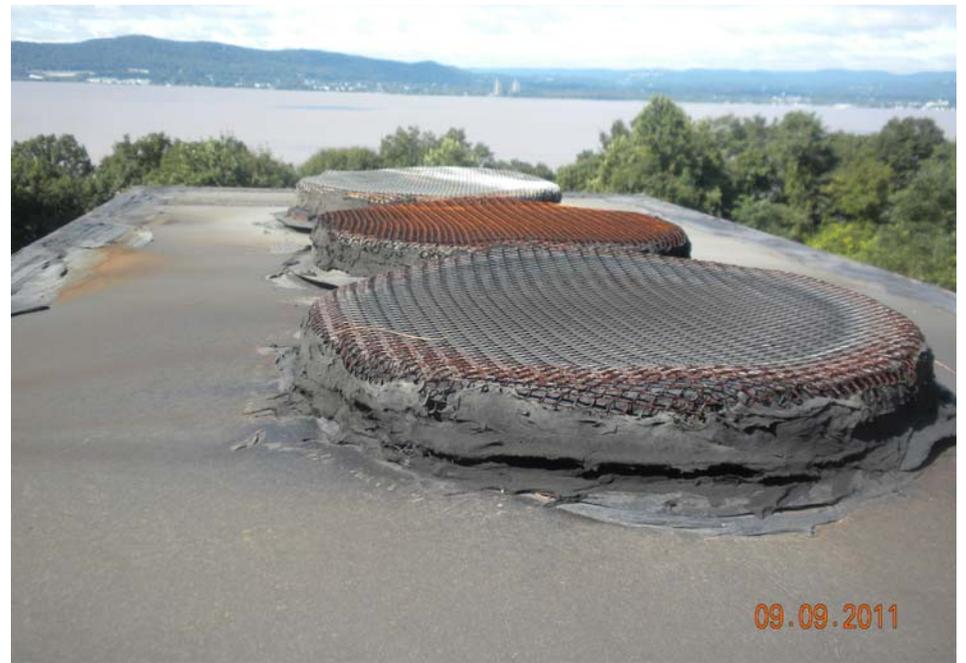
Open joint at chimney flues

- Replace rotted section of wood siding at the east side of the chimney
- Seal open joint at the flues to crown
- Install chimney caps

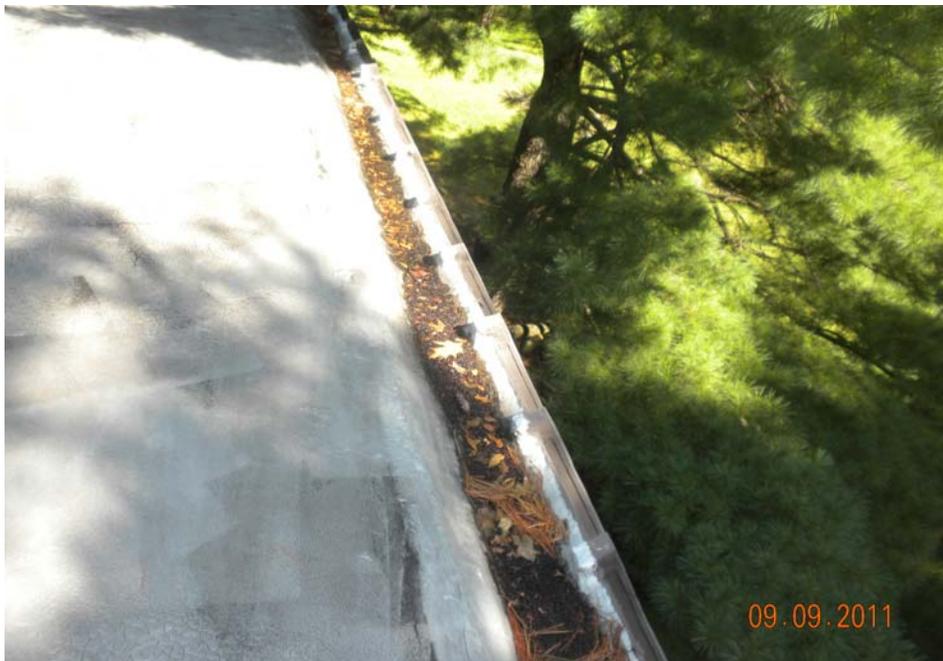
Clogged built-in roof gutters at main house

Existing gutters and leaders should be cleaned several times each year (late spring and late fall). Underground drainage piping is installed at some roof leaders. This is important for removing water away from the structure. Check for good leader base outflow at cleaning periods. Discharge locations were not verified as part of this inspection and should be reviewed with the owner prior to closing. Periodic cleaning of drainage pipes and/or replacement of drywells will be required as part of normal maintenance.

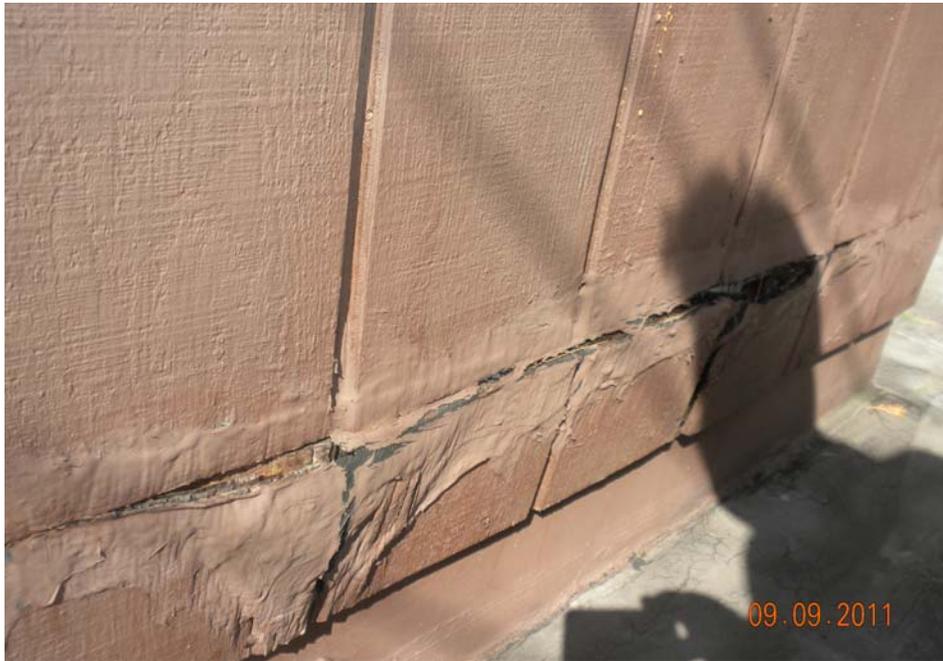
Roof chimney at the Main House is enclosed in wood siding. Chimney maintenance/repairs are needed:

Rotted siding at main house chimney

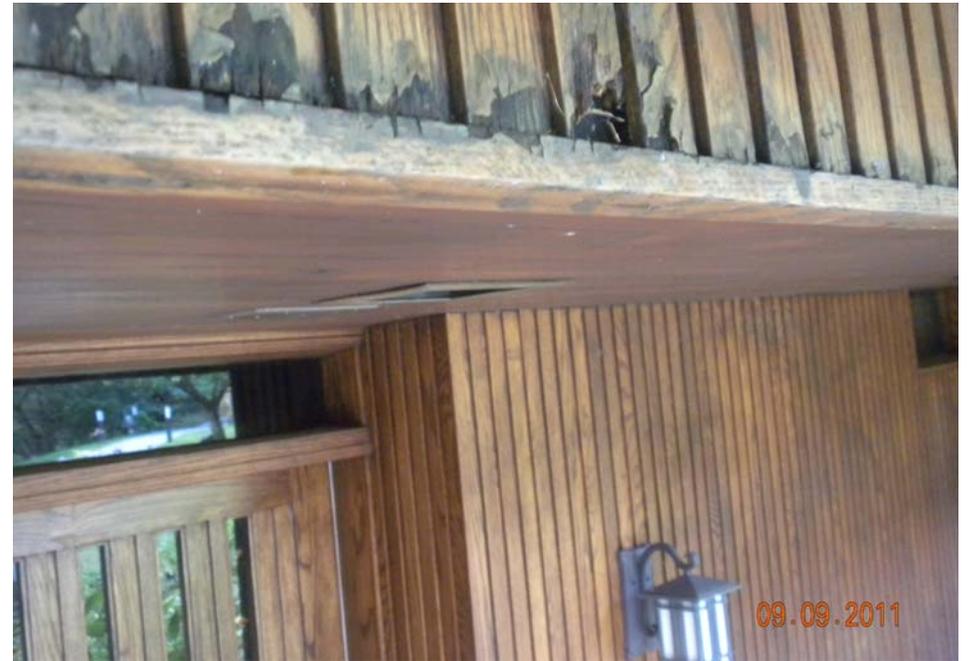
Wood wainscoting siding is installed at the entry door and is in fair condition. Rotted sections at the base of the siding and over the entry door require sectional replacement.

Wood Rot above entry door at main house

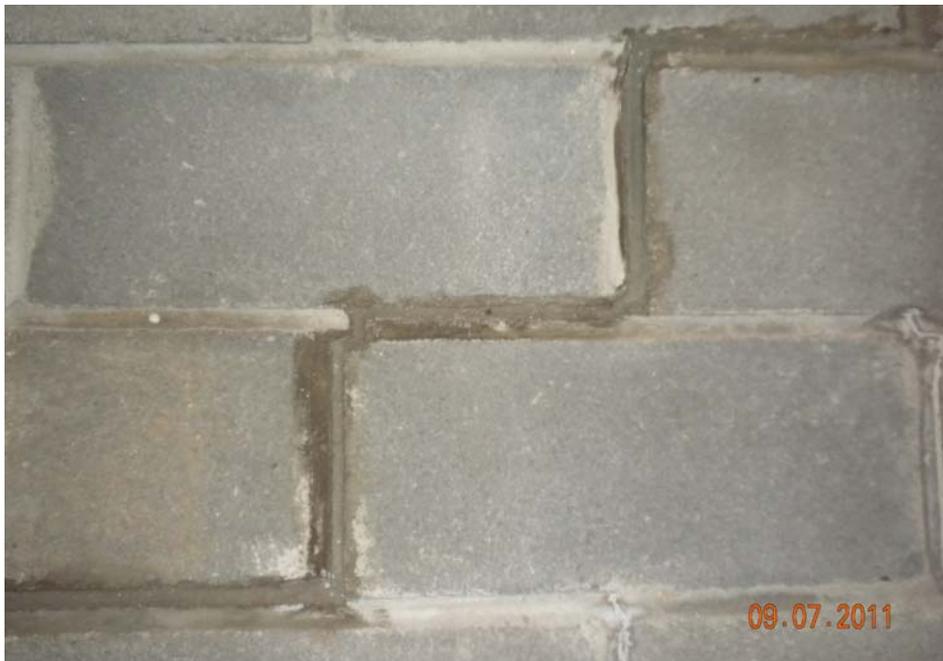
Foundation walls for the Two Car Garage are a combination of concrete and masonry block. More than the normal movement, settlement and cracking have taken place in the west masonry foundation wall of the garage. Cracks have been resealed with mortar materials. On a one inspection basis, it cannot be determined whether this condition will continue. Settlement cracking is not of a major structural concern in its present state. However, cracks should be monitored and, if any further movement is noted, Tri-State should be contracted to re-evaluate this condition.

Foundation cracking at west wall of garage

Removal of vegetation at the south and west side of the garage is recommended. Large tree at the south side of the building adjacent to the cracking should also be removed. Patching spalling stucco at the south foundation is also required.

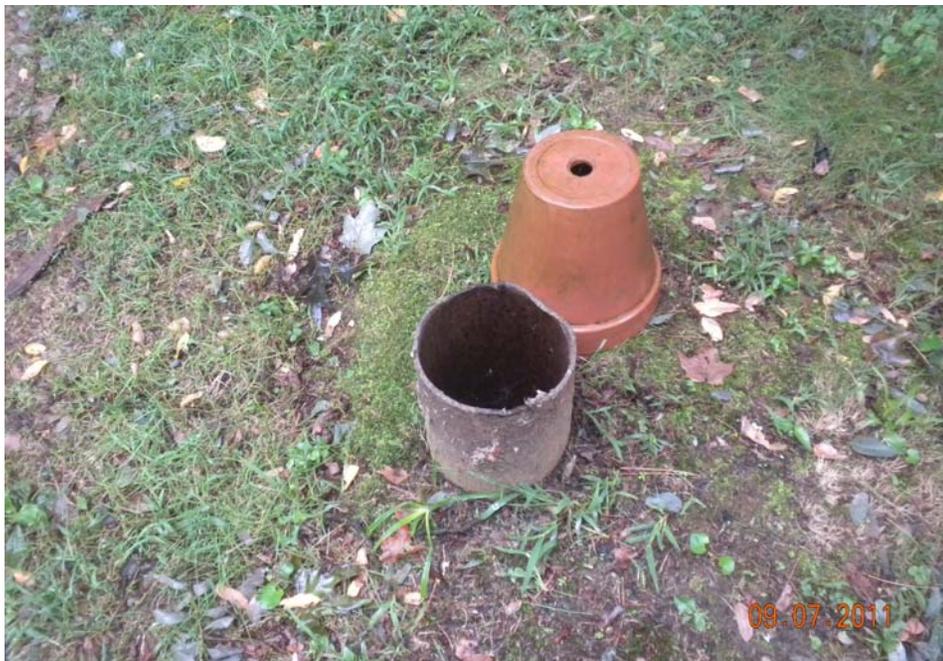
Open well casing needs to be sealed

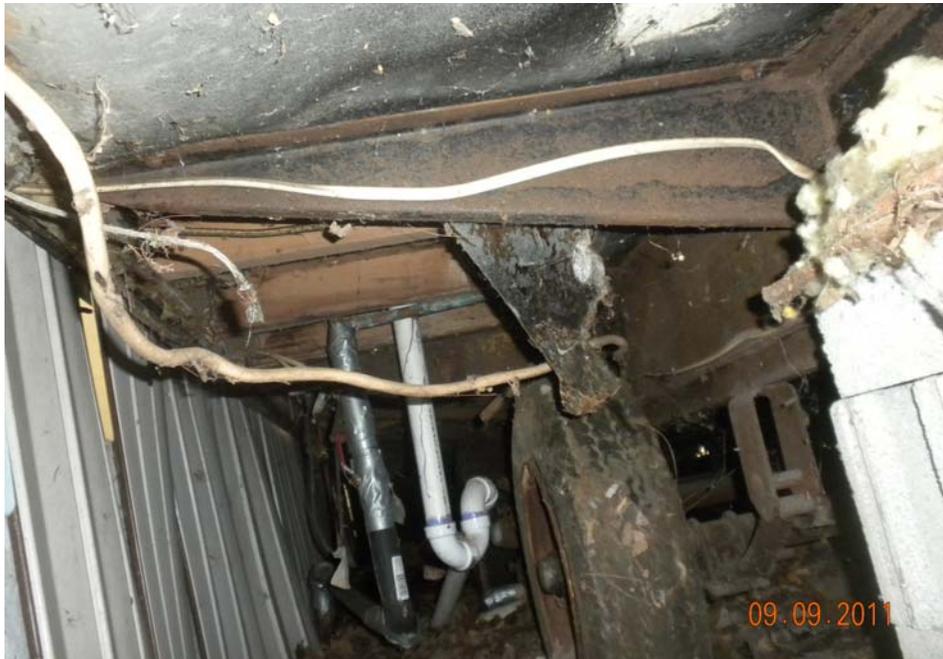
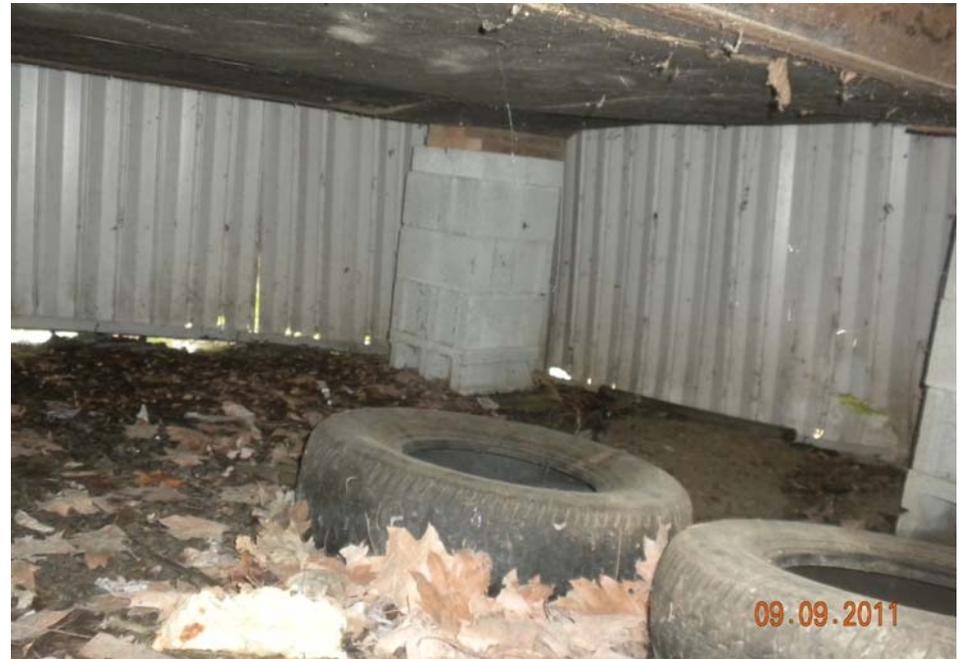
Crawl space under mobile home

Crawl Space under Mobile Home

- 29. The structure is generally in fair condition.
- 30. Vinyl skirt is in poor condition.
- 31. Crawl space under structure should be cleaned out and covered with plastic and crushed stone.
- 32. Sections of the roof have buckled.
- 33. Status of sanitary system is unknown.

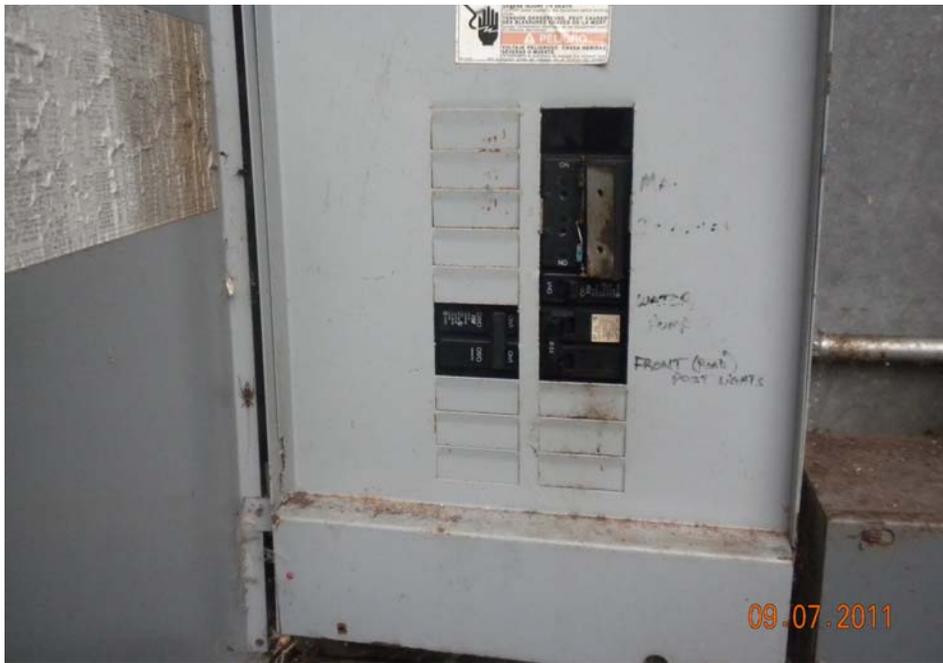
41. The main service is located in a metal panel on the east side of the property. A hole has been cut into the metal panel door. The main electrical service breaker is broken. The main panel cover is not properly installed. A nest was noted inside the panel. Installation of a new weatherproof enclosure/cabinet is recommended due to the hole cut into one of the doors. Up-dating service panel is also recommended.
42. A pond is located on the subject property. Inspection and/or testing of pond water is not included herein.

Main electrical service panel

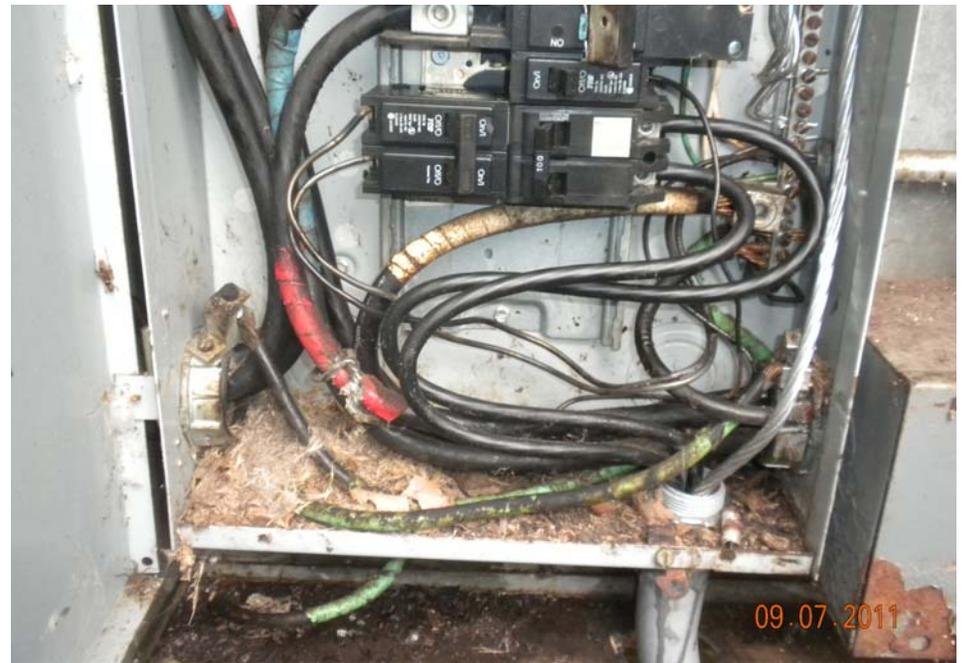
Nest in bottom of main electrical panel

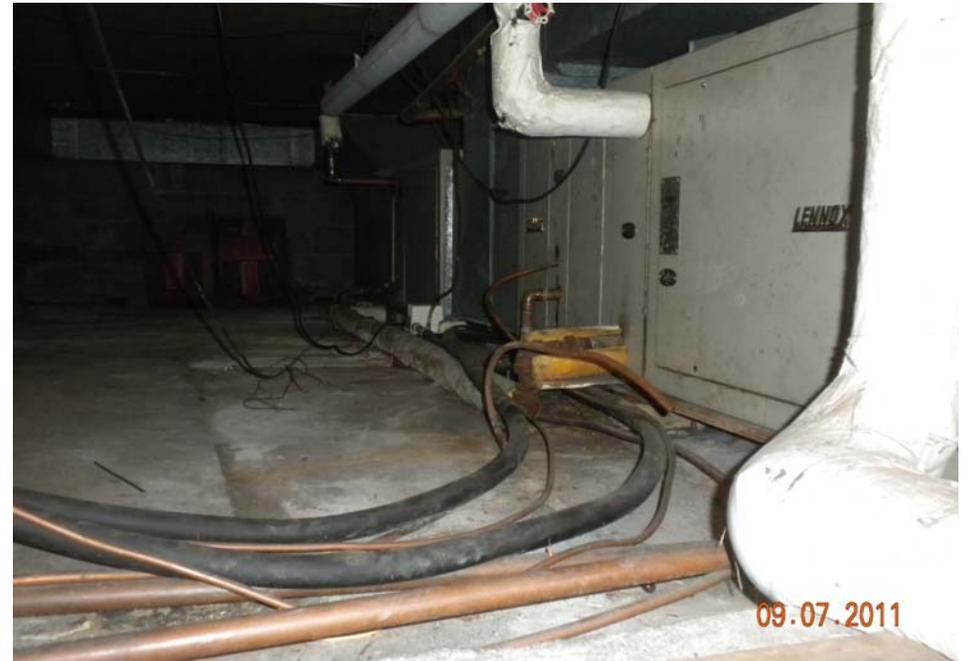
13. The three air handlers are past their normal service life.
14. Exterior glass at window walls and sliding doors should be tempered type for safety.
15. The structure has been treated for termites.
16. The main electrical panel for the main house is manufactured by Federal Pacific. This type of panel has had a problematic history and should be considered a safety hazard. Replacement of panel is recommended.
17. The HVAC system for the lower level was not functional.
18. Up-dating the open railing at the spiral stairs is recommended for safety.
19. The propane fireplace at the lower level was not tested. A 20# propane tank is installed in the boiler room for the fireplace. Tank must be removed for safety.
20. Unit heaters at the lower level bedroom were not functional.

Air handlers at main house are aged
