NEW YORK STATE DEPARTMENT OF ENVIRONMENTAL CONSERVATION

March 11, 2022

Re: Hudson National Golf Course Irrigation Pond Dam, DEC Dam ID#:214-5259
Class A – Low Hazard Dam
Croton-on-Hudson (V), Westchester County

I conducted routine visual inspections at the above referenced dams, all of them Low Hazard Dams, on January 3 and January 6, 2022 in response to a citizen's concern. I am writing to you as it is my understanding that you are, or represent, the owner of these structures, which are associated with Tax Parcel 67.15-1-4 in the Village of Croton-on-Hudson. Copies of my Visual Observations are enclosed for your information.

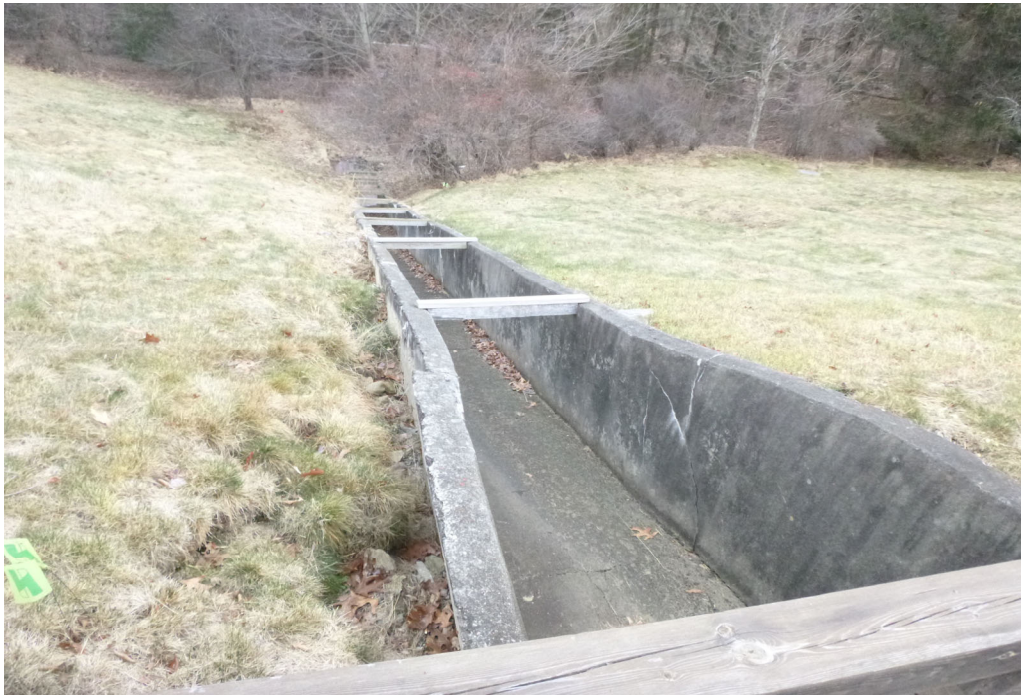
Photo 1 Dam ID# 214-5259 Hudson National Golf Course Irrigation Pond
Dam 01/03/2022
 Spillway Channel.

Wet area at the toe of the spillway with orange floc

A wet area was observed at the spillway chute toe of the HNGC Irrigation and Detention Pond Dams. These wet areas should be monitored to observe if conditions change over time (e.g. flow rate, turbid water).

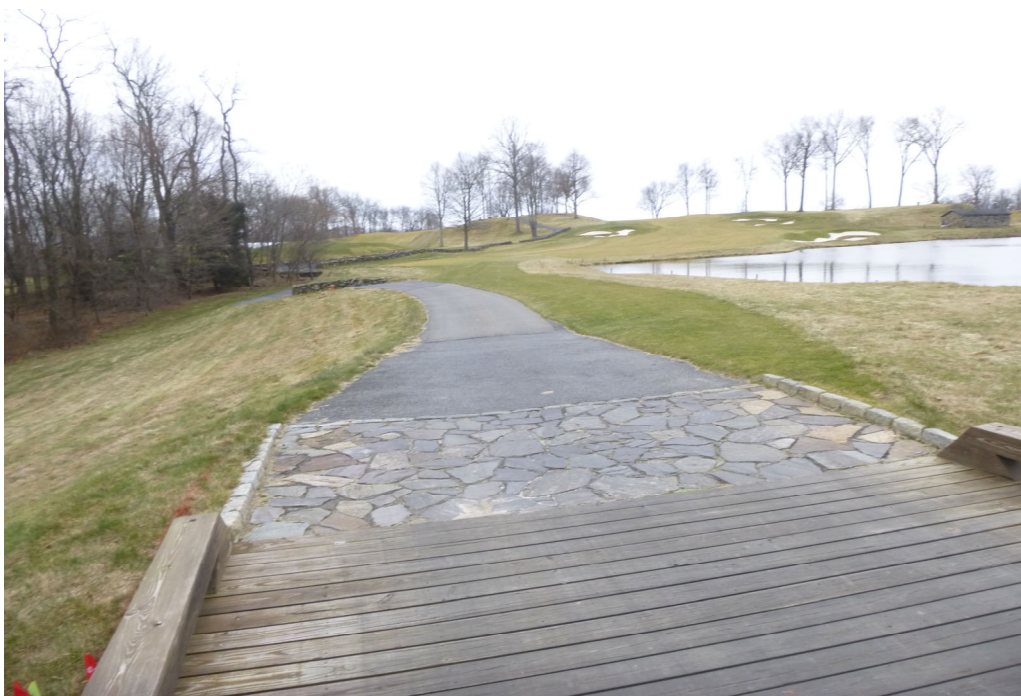
Photo 2 Dam ID# 214-5259 Hudson National Golf Course Irrigation Pond
Dam 01/03/2022
 Dam Crest

Well mowed with grass cover

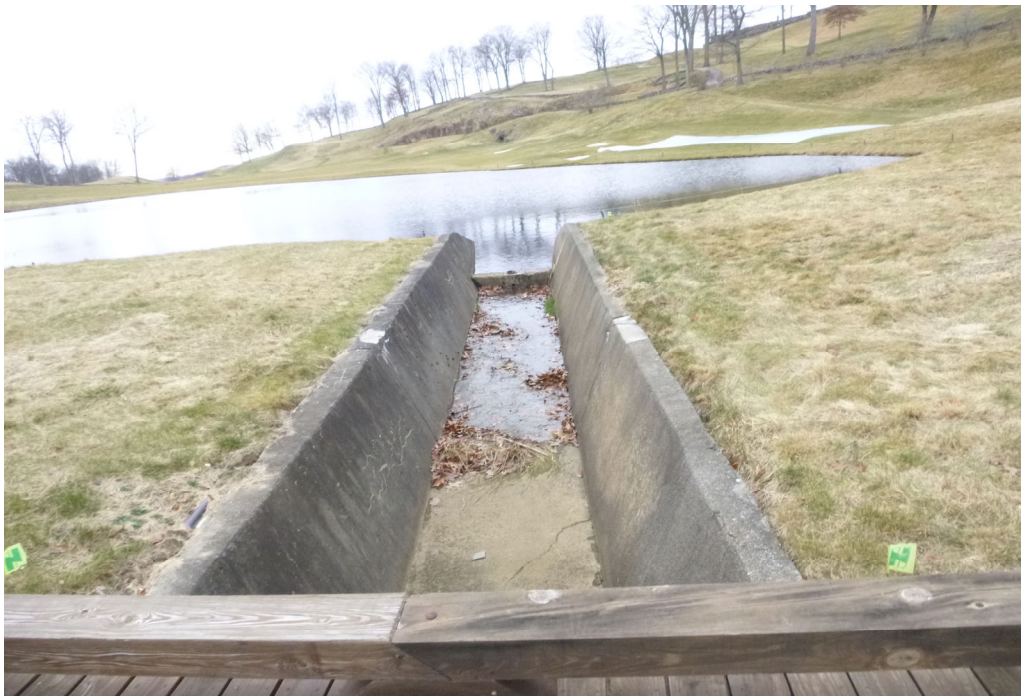
Photo 3 Dam ID# 214-5259 Hudson National Golf Course Irrigation Pond
Dam 01/03/2022
 Spillway looking upstream

Vertical cracks along the spillway walls.

Depression behind left spillway wall.

I recommend that you retain the services of a professional engineer licensed in New York State to assess the dams and plan for repairs. A permit may be needed to rehabilitate the dams.

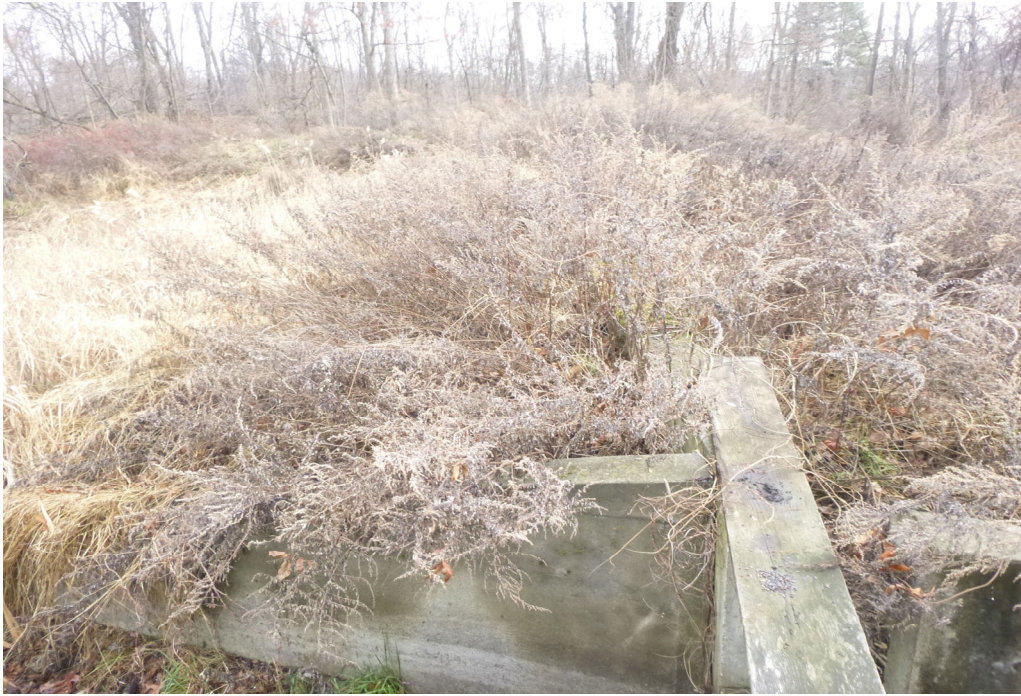
Photo 1 Dam ID# 214-5260 Hudson National Golf Course Detention Pond
Dam 01/06/2022
Dam crest looking toward the left abutment

Assisted by Brett Scales, Golf Course Superintendent.
Too overgrown with brush to properly inspect.

The Hudson National Golf Course (HNGC) Detention Pond and HNGC Pond Dam #2 are too overgrown with undesirable vegetation to properly inspect. The embankment should be always free of undesirable vegetation to allow for a proper inspection.

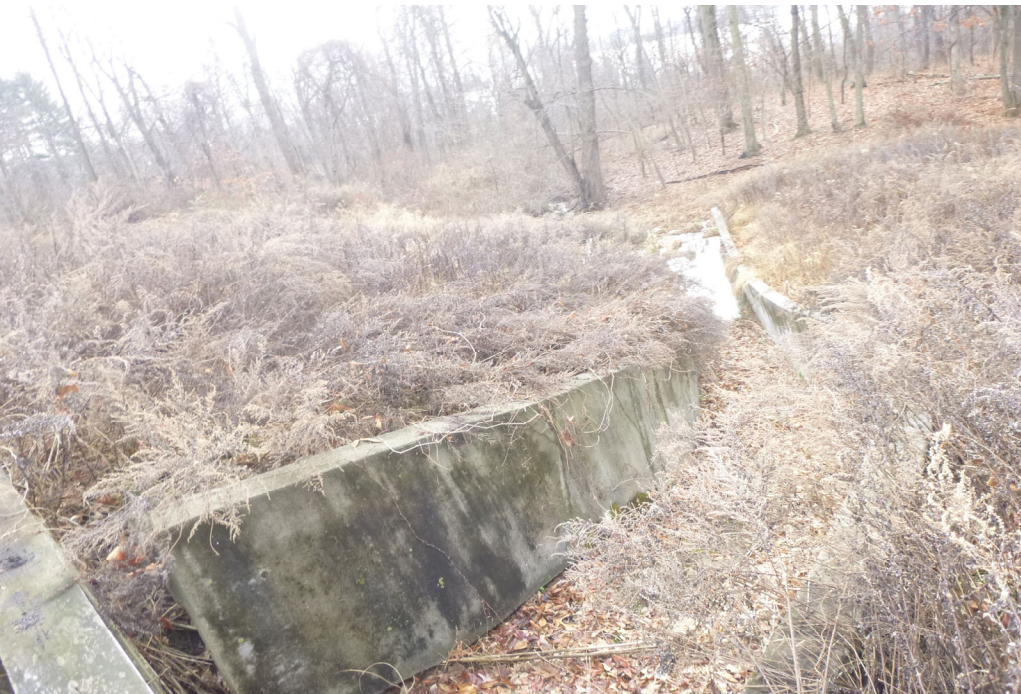
Photo 2 Dam ID# 214-5260 Hudson National Golf Course Detention Pond
Dam 01/06/2022
Service spillway looking downstream

Depression along the left spillway side wall.
Concrete cracking in several spots. Sections of both walls tilting into the channel.
The left spillway wall and weir are separating.

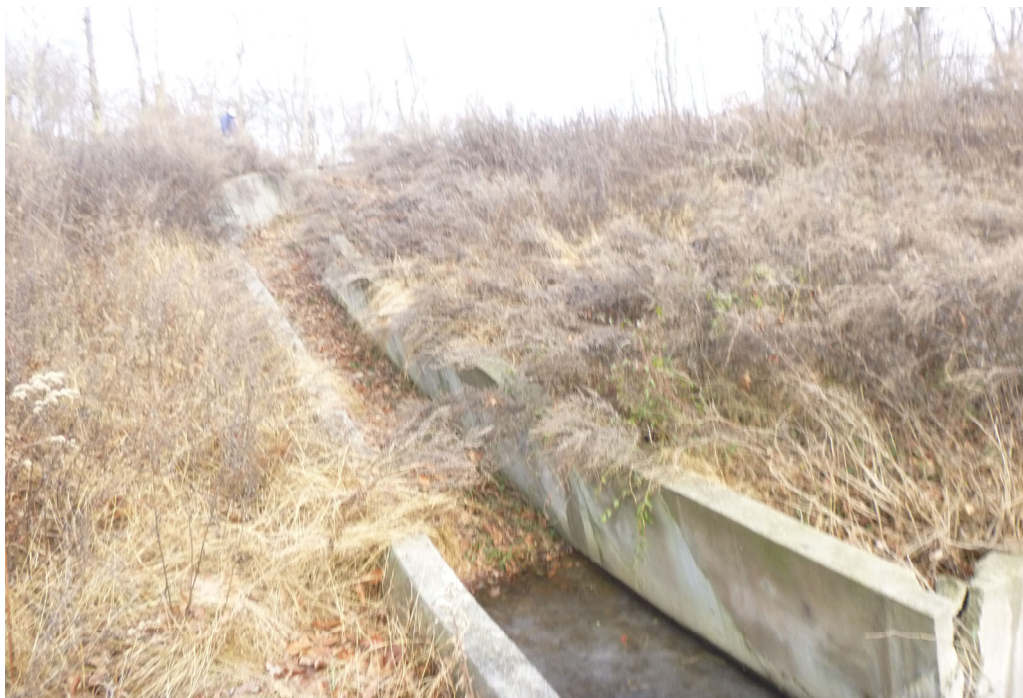
Photo 5 Dam ID# 214-5260 Hudson National Golf Course Detention Pond
Dam 01/06/2022
Spillway chute

Concrete cracking was observed in the HNGC Irrigation and Detention Pond Dams with the weir and left spillway chute wall of the HNGC Detention Pond Dam separating. Also, the chute walls of the HNGC Detention Pond Dam were observed as tilting into the channel.

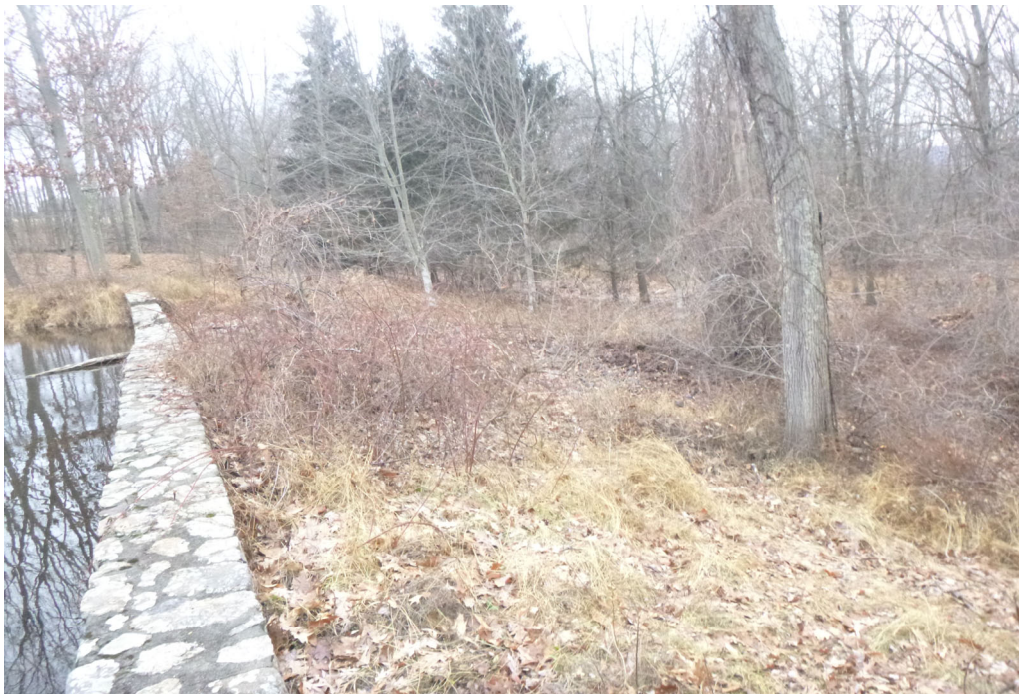
Photo 1 Dam ID# 214-6044 Hudson National Golf Course Pond No 2 Dam
01/03/2022
 Dam crest and downstream slope

Brush and trees.

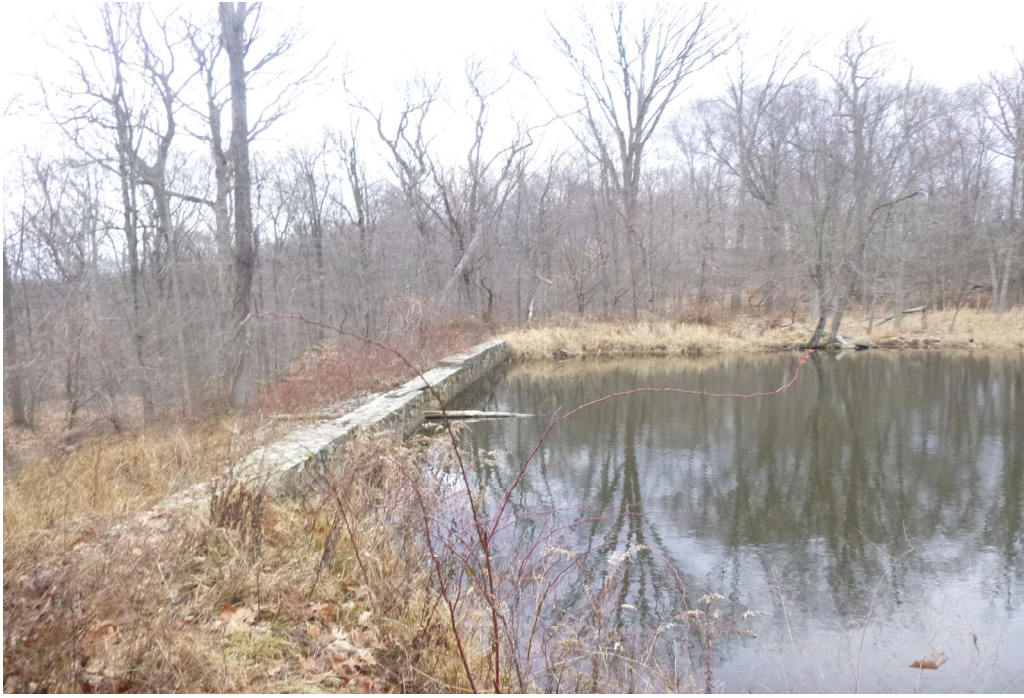
Photo Dam ID# 214-6044 Hudson National Golf Course Pond No 2 Dam
01/03/2022
Upstream face of the dam

Masonry concrete wall along upstream face of the dam.

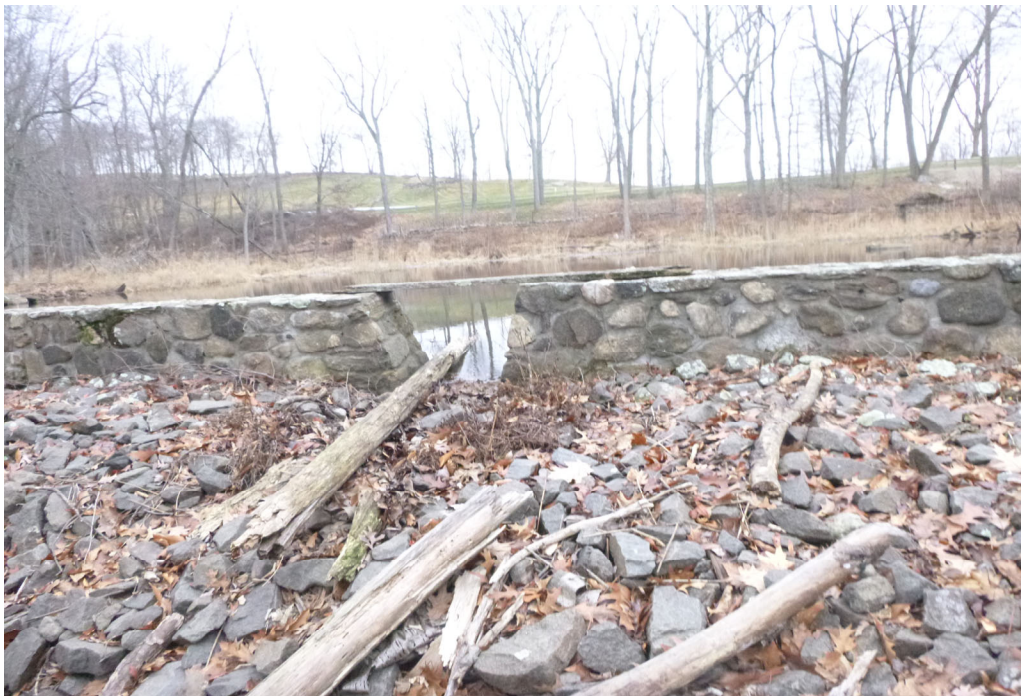
Photo 4 Dam ID# 214-6044 Hudson National Golf Course Pond No 2 Dam
01/03/2022
Downstream view of the spillway.

Wooden log on the crest.
