To: Dan O'Connor, PE
From: Ralph G. Mastromonaco, PE
Date: March 31, 2021
Re: Hudson National Maintenance Area Improvements

This report indicates the history and current conditions of the maintenance area of the Golf Club to provide information on the Club's application for amended Site Plan approval.

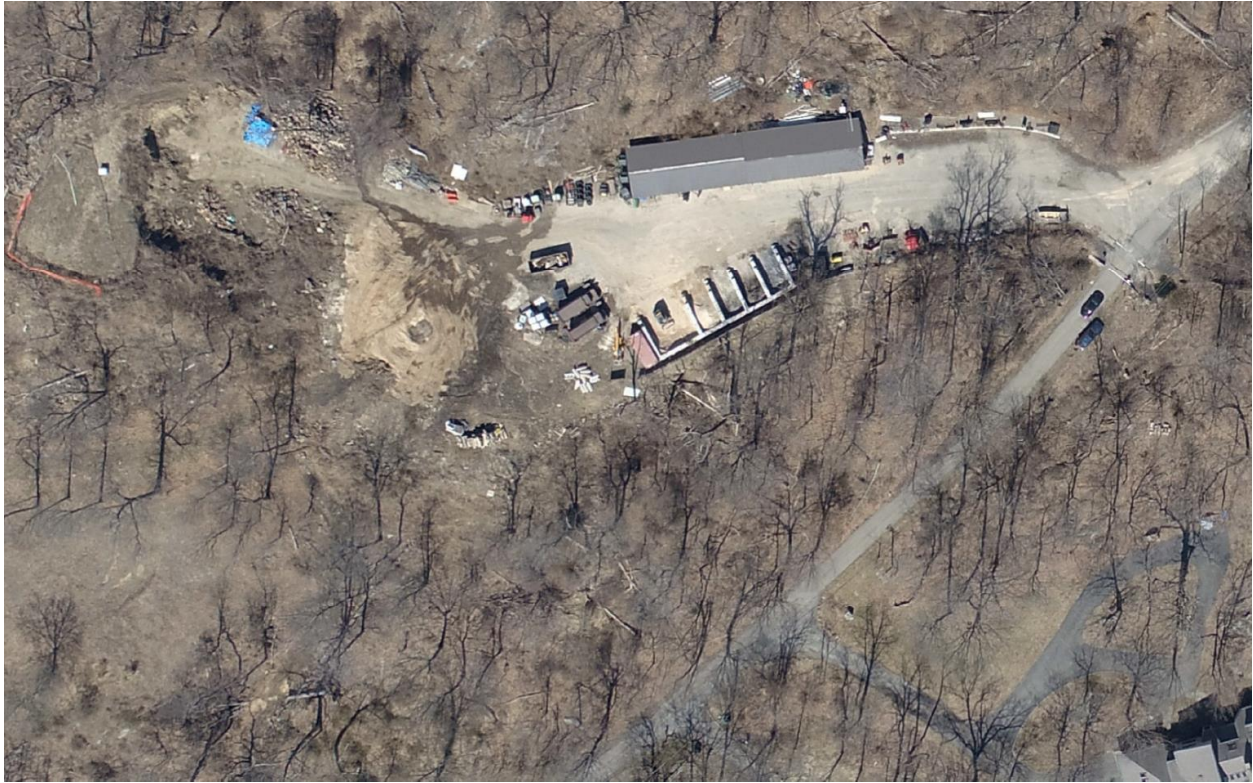
March 2021 – Current Maintenance Area showing shed and material storage.

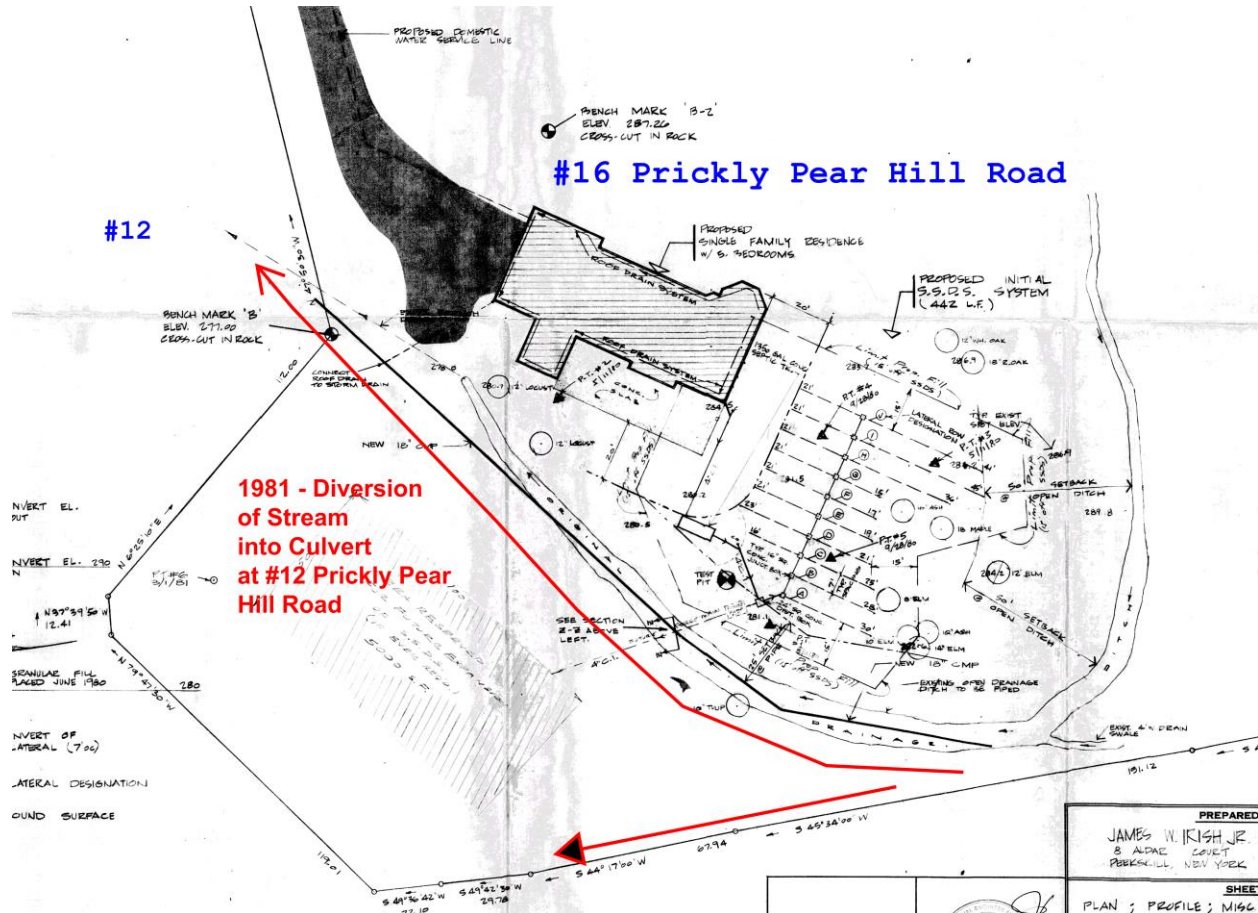
Map of Septic System and Stream Diversion for #16 Prickly Pear Hill Road - 1981

In 1981 the builder of the house at #16 prickly Pear Hill Road diverted a significant portion of the upstream flow to the small channel that runs along the roadway. This diversion added flows to that channel that overtaxes the capacity of the conveyance.

The figure below shows that a new 18" CMP was installed to dry out the proposed septic expansion area of Lot #16 but at the burden of the lots below. This diversion continues today.

Above: the red arrows indicate the direction of stream flows and the diversion to Lot #12 that occurred around 1981 to 1984.

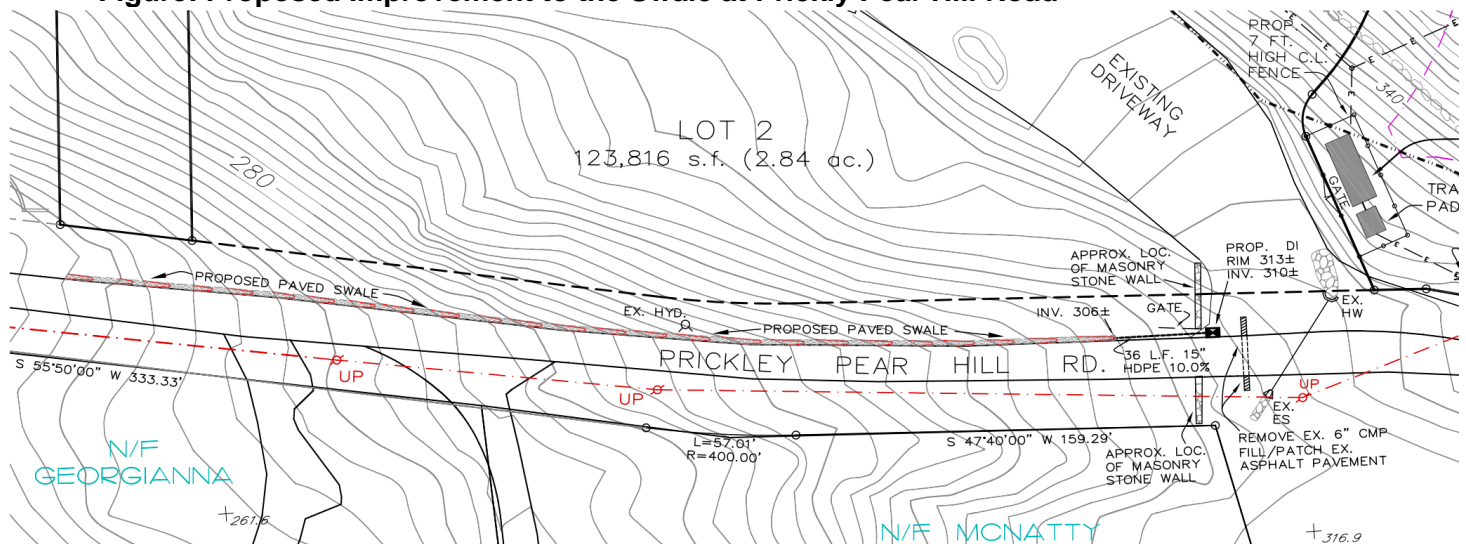
Figure: Proposed Improvement to the Swale at Prickly Pear Hill Road

Several years ago, in an attempt to prevent flow from entering the driveway of a neighbor, the Club installed a pipe and swale to the channel along the frontage of the neighboring properties. To restore the normal flow of runoff, the Club proposes to direct about 1 acre of runoff back to the drainage system on Prickly Pear Hill Road.

This is to be done by installing a catch basin at the driveway that will collect flow and convey it to a short pipe and a new asphalt gutter. This system is capable of handling in excess of the 100-year storm event.

Further, the trench that was cut across the roadway years ago will be filled to grade and the pipe will be removed. The original 12" corrugated metal pipe that has been in operation since before 1995 will remain in place.
