Section 2.0 Existing Conditions

The study area for Indian Brook-Croton Gorge Watershed Conservation Action Plan, (the plan), is limited to the portion of the Croton River watershed within Westchester County that is downstream of the New Croton Dam. This portion is identified as the Croton Bay Watershed and serves as an important tributary to the Hudson River.

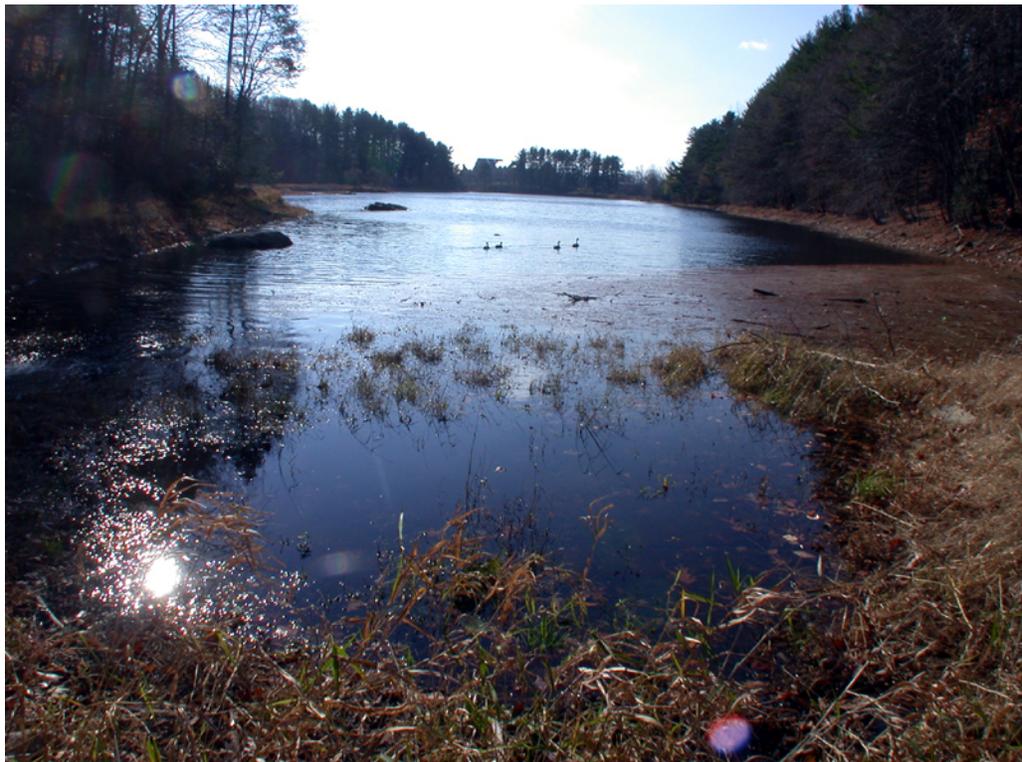
Figure 2-13. Indian Brook Reservoir, Ossining, NY

The Indian Brook Reservoir serves as a drinking water source for the Town and Village of Ossining. In 2004, the Indian Brook Plant pumped over 15 million gallons of water each month from the Reservoir, with a maximum of 58 million gallons, totaling 555 million gallons for the year. The Indian Brook Reservoir is surrounded by forest. Three inlet streams to the Reservoir and one outlet stream exist and vary between 4-10 feet wide and vary between 3-8 inches deep. The overall water quality rating based on the Indian Brook Streamwalk for the Reservoir was good. The noted areas of concern for the Reservoir included streams that were flowing directly into it. Streambank erosion was identified along the northern inlet stream. This erosion can contribute to increased turbidity and silting of the stream

and the Reservoir. The eastern inlet stream of the Reservoir was reported to have poor canopy cover, which can affect the habitat quality for stream organisms. It was also noted to exhibit poor insect and invertebrate habitat, which can affect the viability of the stream ecosystem.
