## PROJECT STATUS UPDATE: 2021 CROTON HYDRILLA CONTROL PROJECT

**REPORT DATE: 07/26/21-08/06/21**

**Project Description:** This is the 5<sup>th</sup> year of hydrilla treatment in the Croton River based on a 5-Year management plan. After successful treatments in 2017, 2018, 2019, and 2020 the treatment proposed for 2021 again involves the injection of the aquatic herbicide fluridone (Sonar Genesis®) into the river just below the New Croton Dam and at Black Rock Park with a target concentration of 2.0-4.0 parts per billion (ppb) for 90-120 days. Drinking water sample reports are posted on this DEC webpage: <https://www.dec.ny.gov/animals/110624.html>

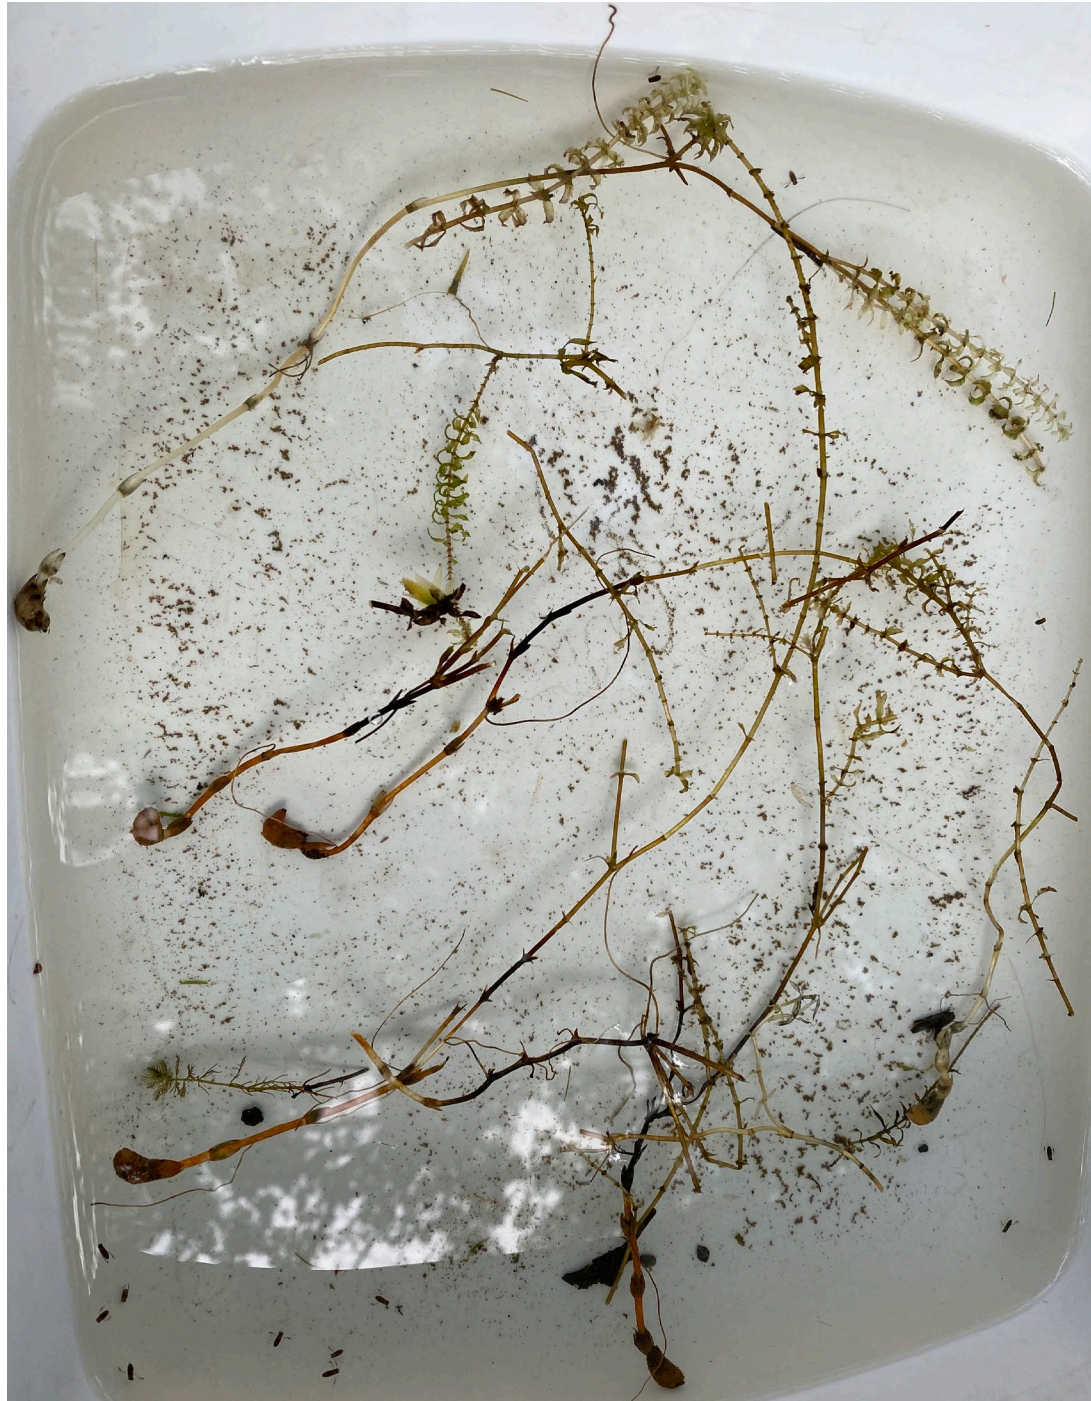
Black Rock Park 7/28/21

Hydrilla – Snorkel/SCUBA survey

~7 Weeks After Treatment

6 plants with tubers

1 turion

Zero floating fragments

All plants show significant impacts  
from fluridone treatment

-chlorosis

-defoliation

-stunted growth

No other hydrilla was found

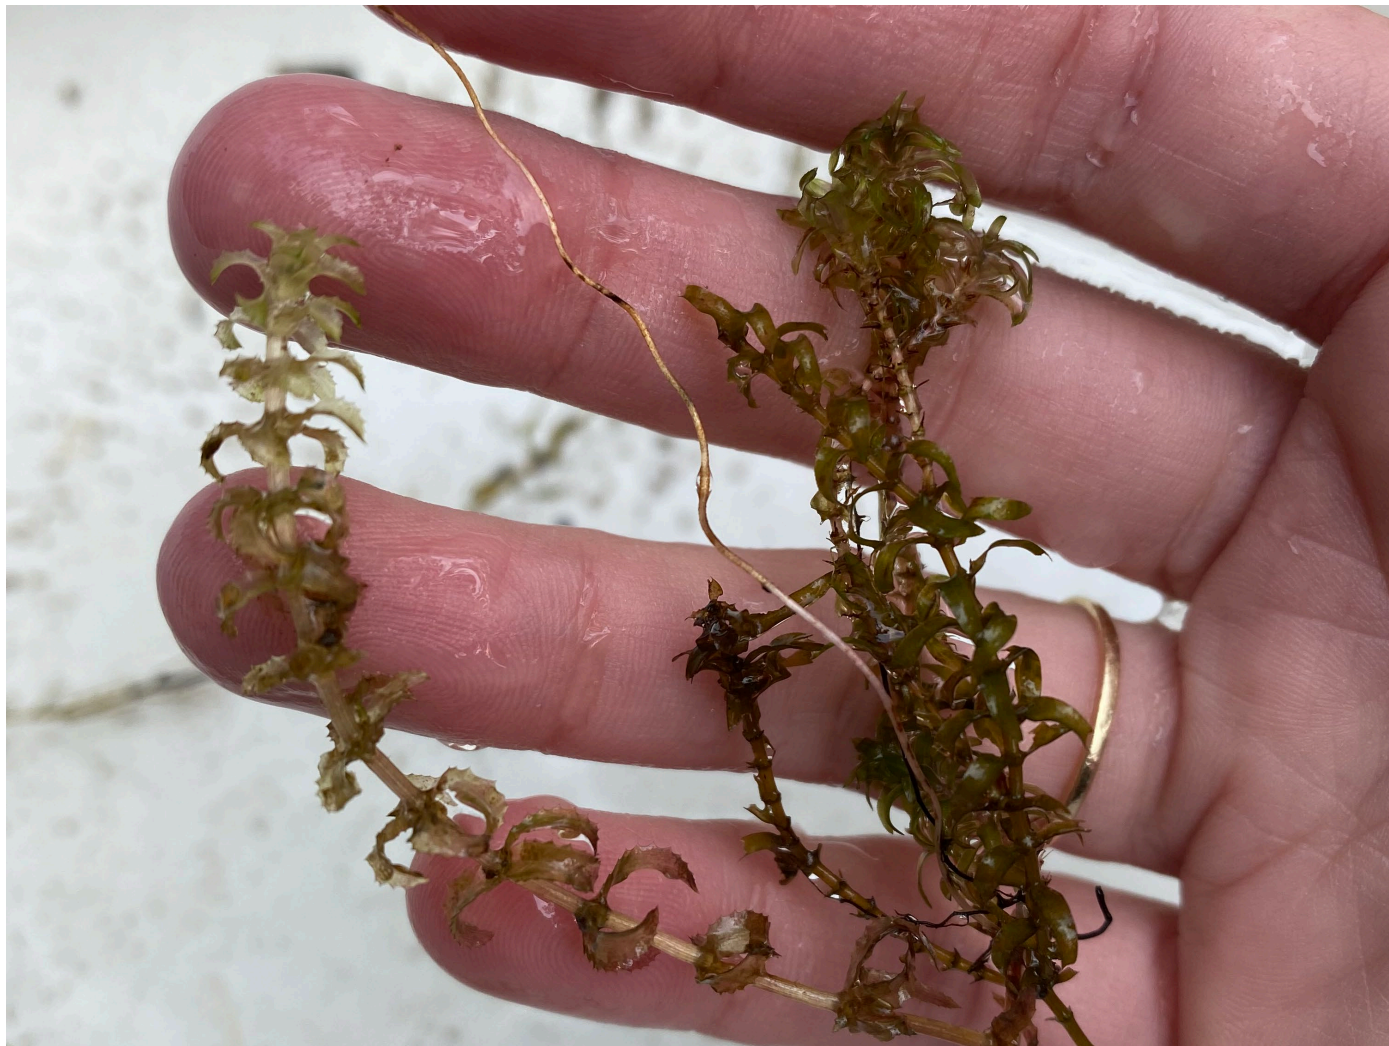
Comparison of plant condition from Croton River  
7/28/21

Invasive Hydrilla – LEFT

Native Elodea – RIGHT

Both species show defoliation, Elodea shows less  
chlorosis
