Croton Hydrilla Control Project

2018 ANNUAL UPDATE

**CROTON HYDRILLA CONTROL PROJECT
2018 ANNUAL UPDATE**

Division of Lands and Forests
Bureau of Invasive Species and Ecosystem Health

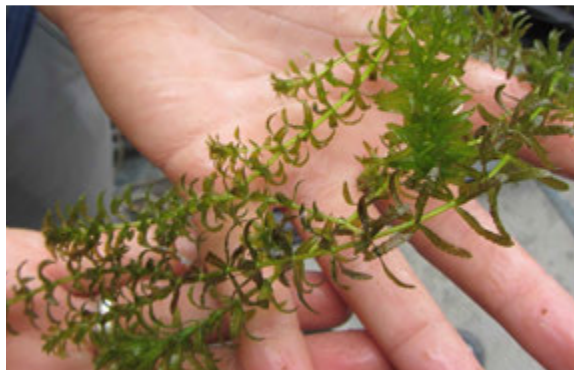
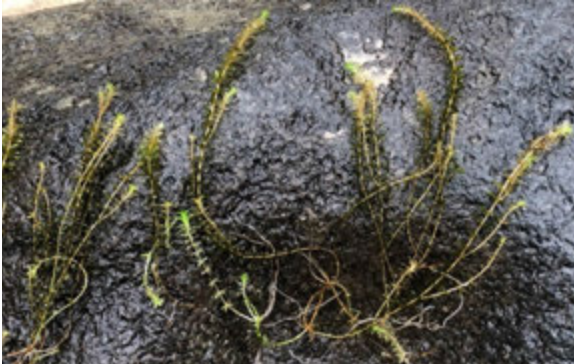
Figure 1: Healthy hydrilla in Croton River in 2016 (top), and damaged, chlorotic hydrilla following the second treatment season in 2018 (bottom).

- Hydrilla plants occurred in trace and sparse abundance in 2018. No moderately dense or dense populations were observed.
- During treatment, hydrilla plants showed significant signs of injury and impacts to plant fitness.

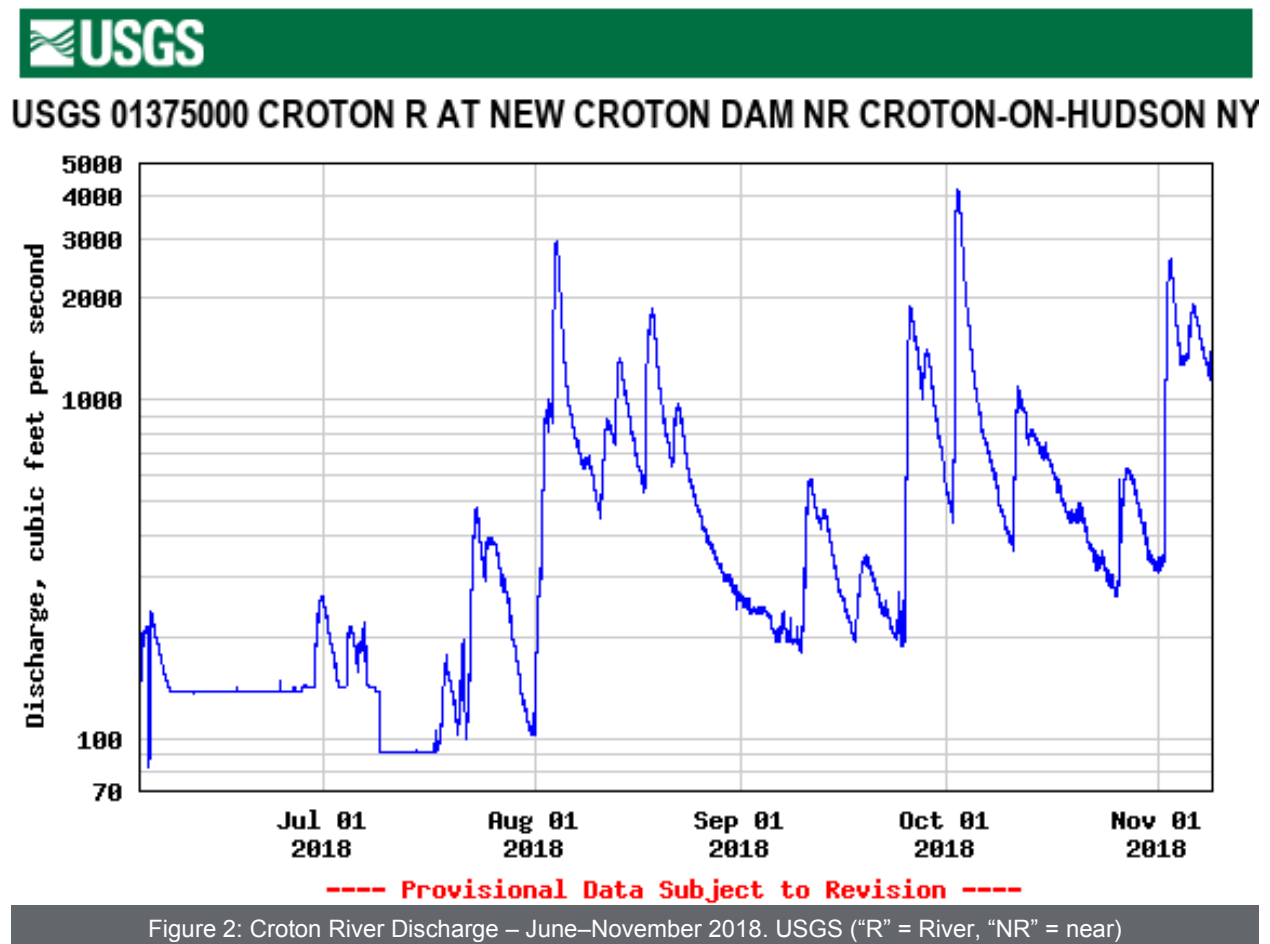
Sustained and record rainfall amounts caused treatment shutdowns throughout the 2018 season. A Pesticide Discharge Management Plan (PDMP) was developed as an operational protocol as part of the State Pollutant Discharge Elimination System (SPDES) permit. In 2018, the PDMP for this project targeted treatment in waters flowing at a rate less than 500 cubic feet per second (cfs) in an effort to ensure fluridone concentrations would remain within the target range of 2.0-4.0 parts per billion (ppb). Discharge (the volume of water in the Croton River) results from a combination of controlled bottom releases (using doors at the base of the New Croton Dam) and water spilling over the top of the Dam. Discharge is measured at the United States Geological Survey (USGS) Hydrological Station 01375000 (located along the Croton River, 1,000 feet downstream of the New Croton Dam). Discharge regularly measured above 500 cfs during the 2018 treatment season including during intense storms in August and October (Figure 2). In total, 55 treatment shutdown days occurred during the 2018 treatment season due to storms. The longest shutdown period occurred following storms during August and lasted 14 consecutive days.

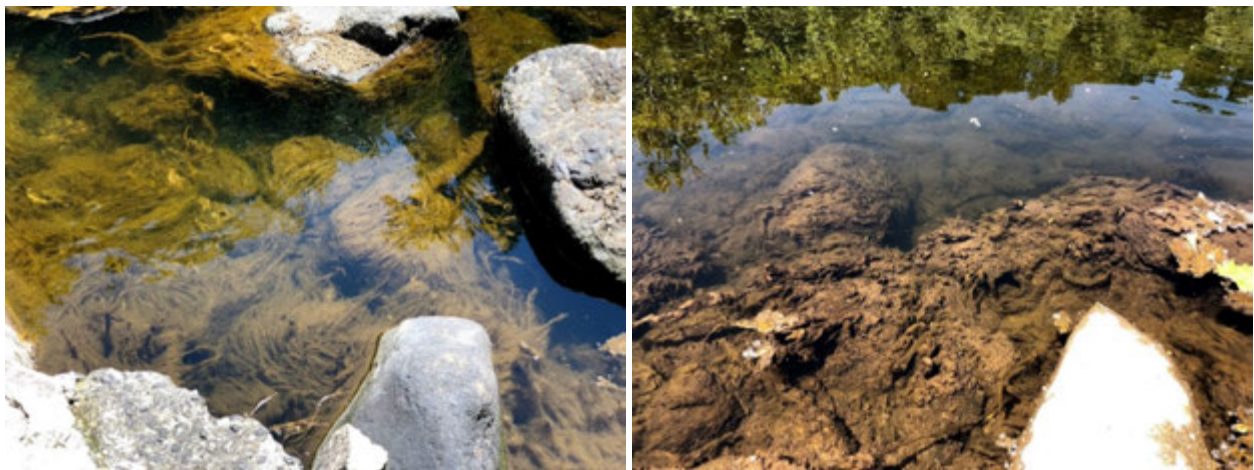
Figure 3: Didymo at Croton Gorge Park (left) and Silver Lake Beach (right), 2018.

A bloom of didymo (*Didymosphenia germinata*), also known as “rock snot,” occurred in the Croton River during the spring and summer of 2018. While didymo has been found in the West Branch of the Croton River in the past, the extent and magnitude of the 2018 bloom was unprecedented. Didymo was also found in Indian Brook, which is a tributary to the Croton River and located upstream of the fluridone treatment. Didymo is a microscopic algae (diatom) that can form thick brown mats on stream bottoms (Figure 3). Didymo blooms typically occur in cool, clear, nutrient-poor water. It is possible that the thick growing mats impacted the early 2018 hydrilla growth by limiting the amount of sunlight reaching the bottom of the river. The didymo bloom was scoured away during intense rainfall in July and August 2018.

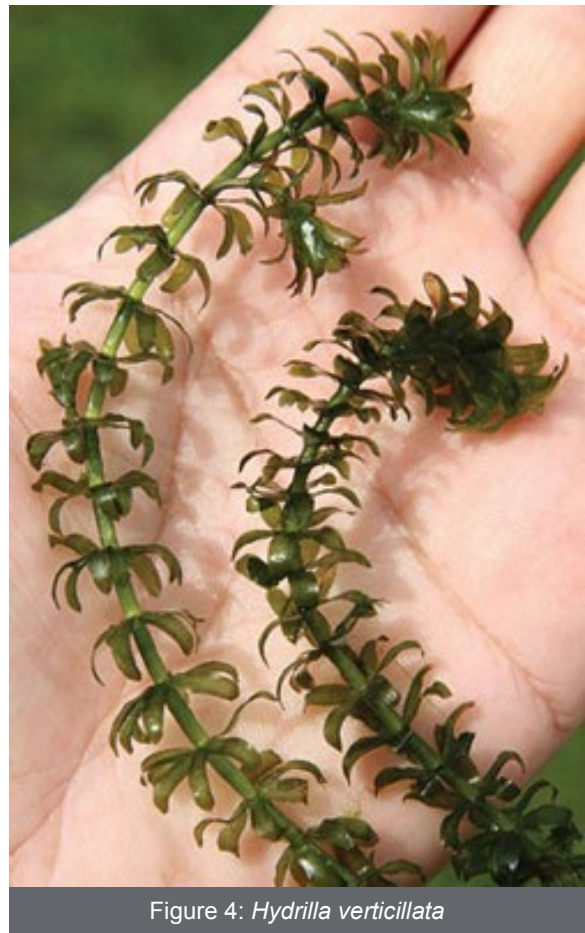
Figure 4: *Hydrilla verticillata*

In New York State, hydrilla is a perennial plant that emerges in late spring to early summer and grows along the bottom of wetlands, rivers, streams, lakes, and ponds. Its monoecious form (containing both male and female organs on the same plant) is capable of overwintering in New York State. Hydrilla can grow up to an inch per day, producing dense mats of vegetation that extend from the river bottom to the surface of the water. The dense mats displace the native plants that provide the food, water, and shelter for native aquatic wildlife.

To propagate, hydrilla can produce seeds, green buds called turions, and tubers that grow in the sediment at the end of the roots and store energy. New populations of hydrilla can sprout from seeds, turions, and tubers, as well as from plant fragments that easily break off of the plant. These extremely effective dispersal methods make manual control of hydrilla extremely difficult in New York State.

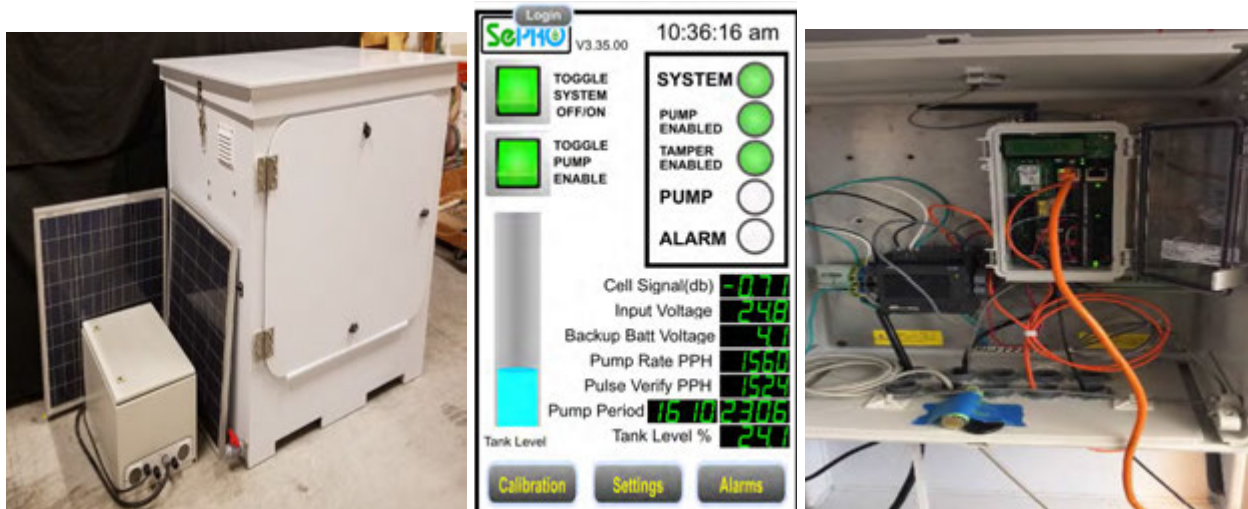
Figure 5: A fluridone injection unit (left), unit control dashboard (center), and cellular control device (right). SePRO

The first injection site was located just below New Croton Dam and a second injection site was located near the concrete dam at Black Rock Park. Injection locations were selected in order to maximize treatment coverage and ensure product mixing (that the herbicide mixed

with the water). Staff from SÖLitude Lake Management and SePRO Corporation installed, calibrated, and maintained the units. A licensed pesticide applicator from SÖLitude Lake Management filled and refilled the injection unit tanks. The actual dosage and duration of the application were determined daily by flow rates in the river using discharge measurements from the USGS Hydrologic Station 01375000 (located just below the New Croton Dam), as well as the observed efficacy and label requirements of Sonar® Genesis. Pump rates were calculated daily and controlled by accessing a dashboard using a cellular device or laptop computer. Unit operation was conducted by SÖLitude Lake Management-licensed applicators and SePRO staff.

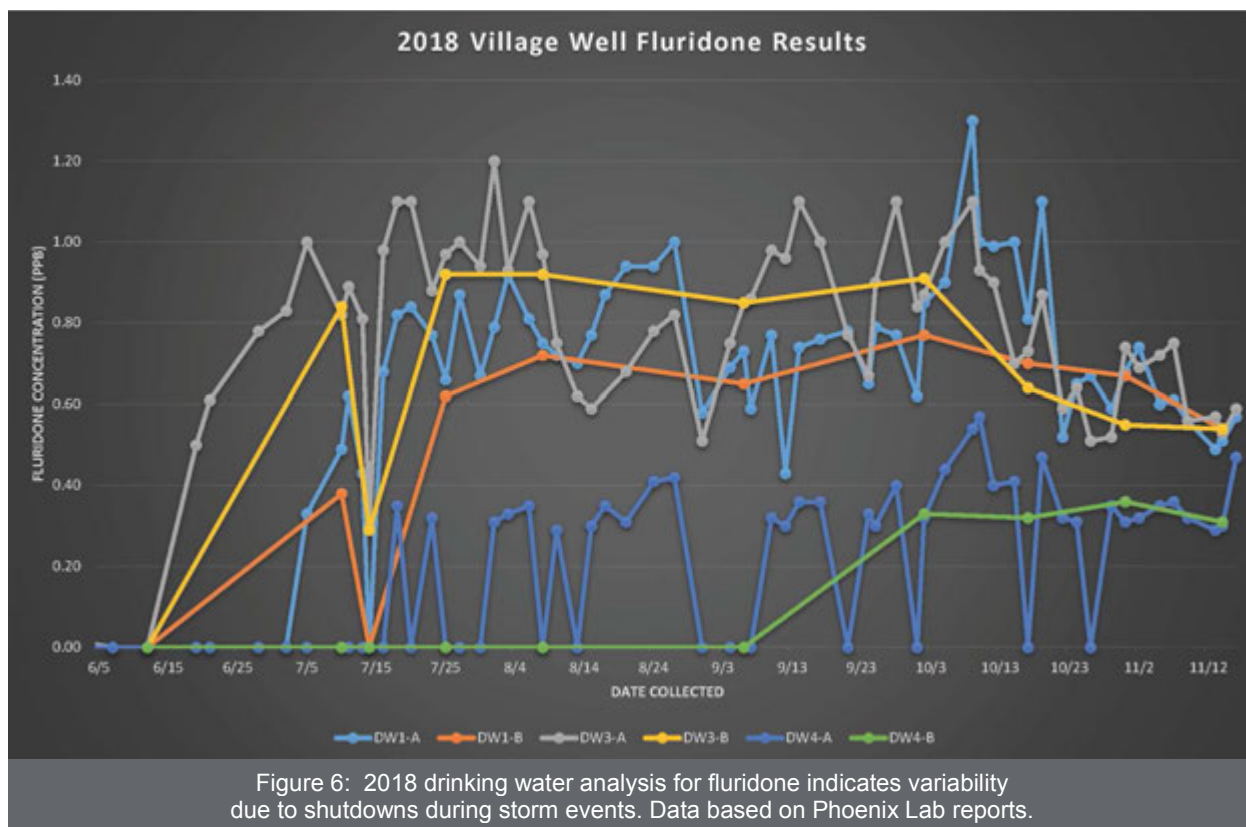
Drinking water sampling began on June 7, 2018, and was conducted twice per week until fluridone levels exceeded 1.0 ppb in drinking water well #3 (DW3) on July 5, 2018. Beginning July 10, 2018, water sampling was conducted three times per week until November 27, 2018, when fluridone concentrations dropped below 1.0 ppb at all water sampling locations. Sampling was then conducted weekly until two consecutive samples with readings of “non-detect” were found at all water sample locations (this occurred January 23, 2019). The highest fluridone concentration during the 2018 treatment season was 1.3 ppb, well under the 4.0 ppb limit set by this project. Phoenix Lab reports containing sampling results from the finished water and drinking water were posted to the Croton Hydrilla Project’s Water Sample Analysis Results Page on the DEC website (<http://www.dec.ny.gov/animals/110624.html>). Figure 6: 2018 Village Well Fluridone Results and Figure 8: 2018 Distribution System (Finished Water) Results display the fluridone concentrations throughout the 2018 treatment season. Graphs were generated using data from the Phoenix Lab reports.

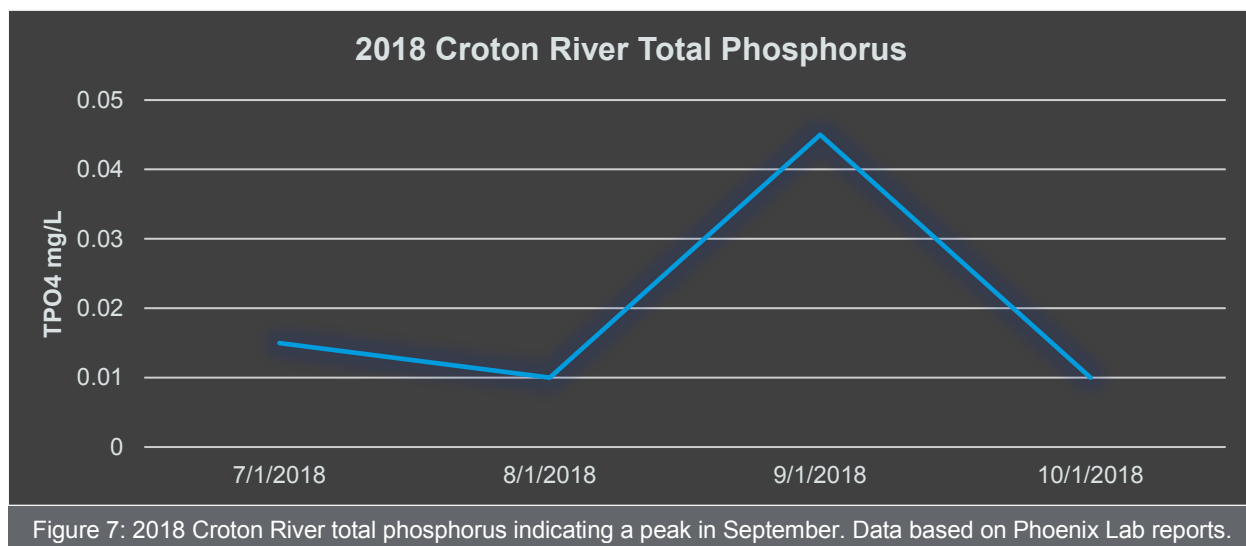
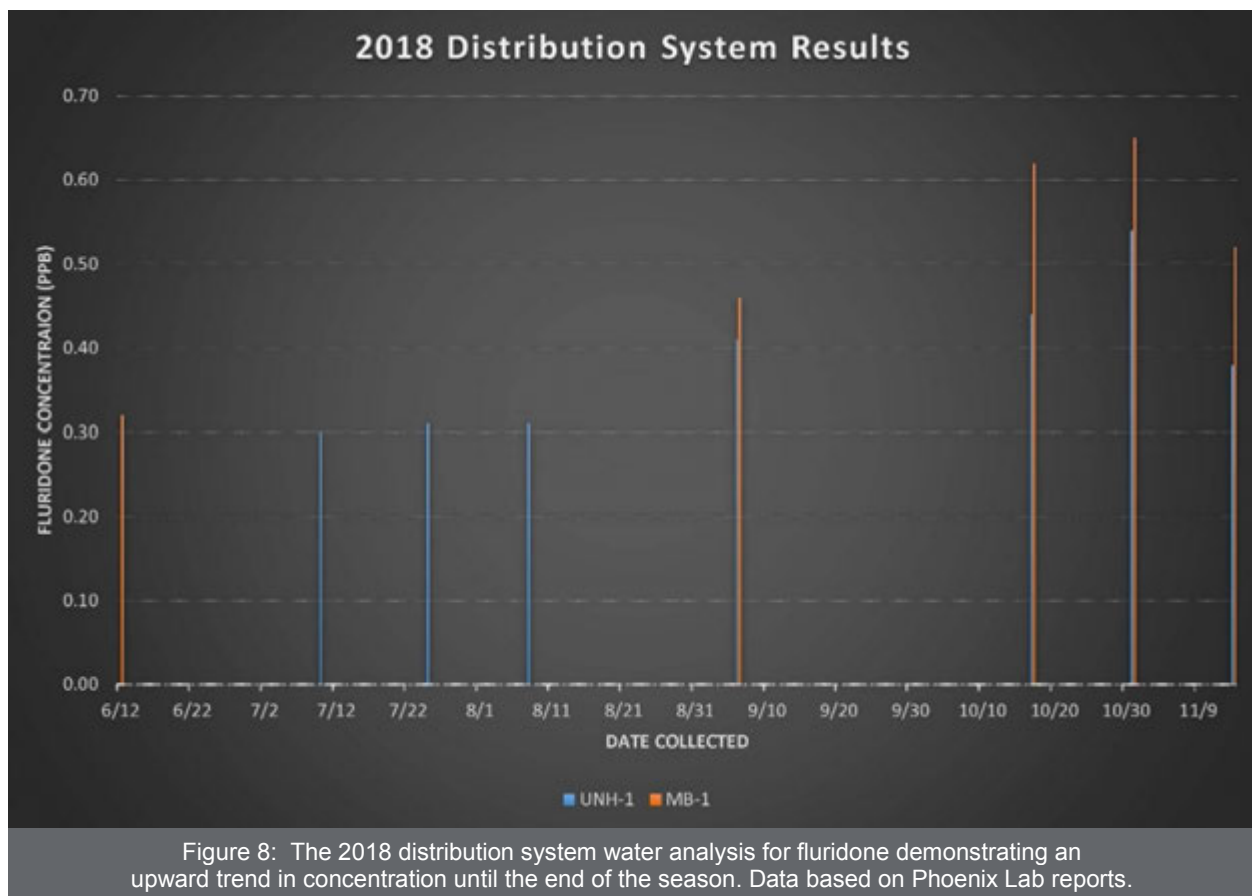
Additionally, river water samples were collected weekly by SŌlitude Lake Management at five sites along the Croton River (CR 1, CR 1.5, CR 2, CR 3, and CR 4) and were analyzed for fluridone by SePRO Research Lab in Whitaker, North Carolina using the FasTEST method to an accuracy of 1.0 ppb. FasTEST sampling concluded for the season on November 14, 2018, following the end of treatment and all river site samples reporting non-detect for fluridone.

In addition to sampling for fluridone, SŌlitude collected water samples on July 2, 2018; August 1, 2018; September 19, 2018; and October 17, 2018, to test total phosphorous (TPO4). Figure 7: 2018 Croton River Total Phosphorus contains TPO4 data based on Phoenix Lab reports.

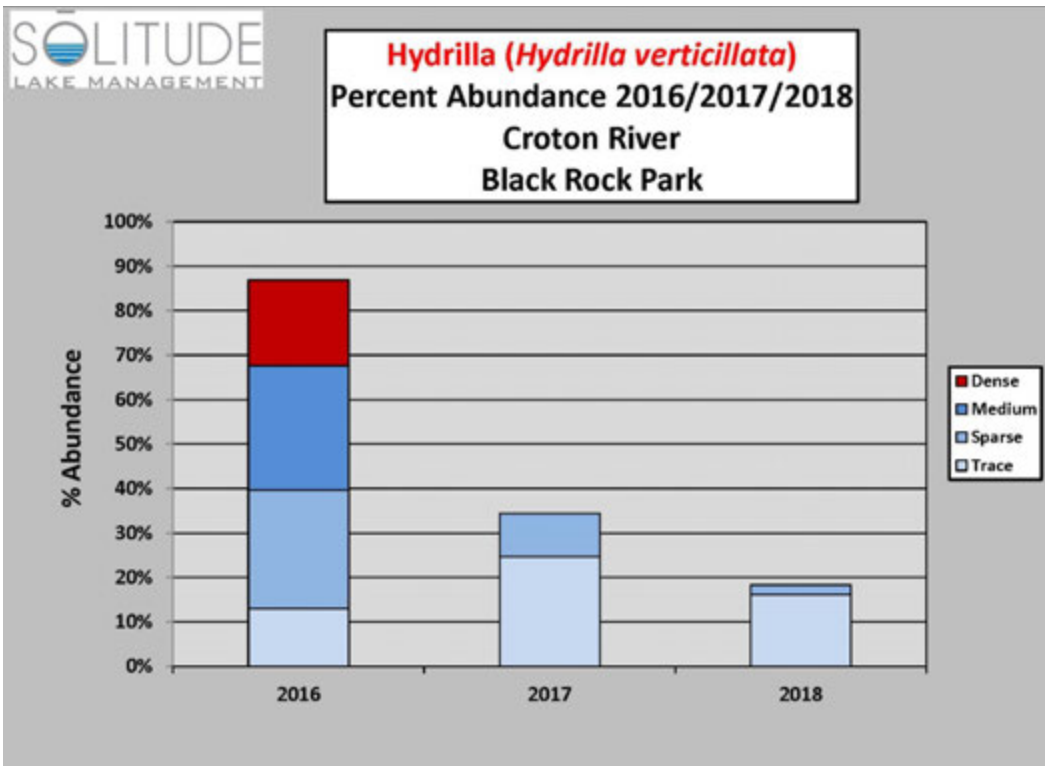
Figure 9: 2016 to 2018 Percent Abundance – Croton River: Black Rock Park

Significant decreases in the number of sites with hydrilla and the overall abundance of hydrilla at each site were observed following treatment in 2018. The vast majority of hydrilla plants showed signs of herbicide injury, although some showed signs of recovery following treatment shutdowns. Figures 8, 9, 10, 11, 12, and 13 show the declines in percent abundance for each section of the Croton River surveyed in 2018.

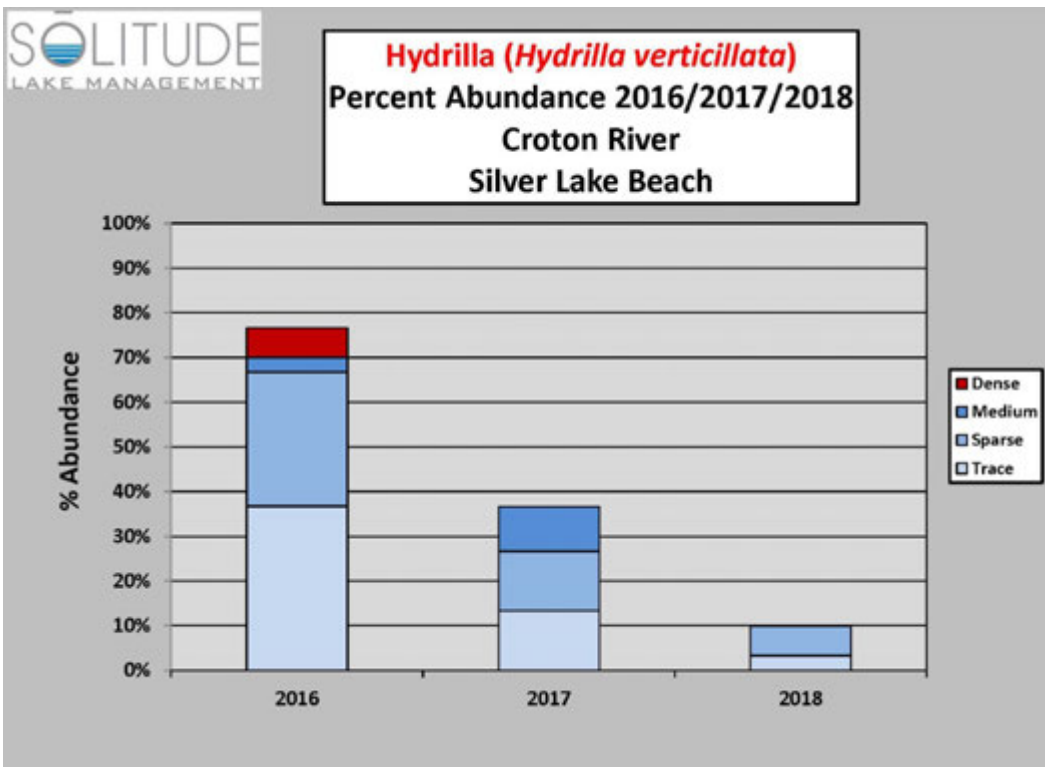
Figure 10: 2016 to 2018 Percent Abundance – Croton River: Silver Lake Beach

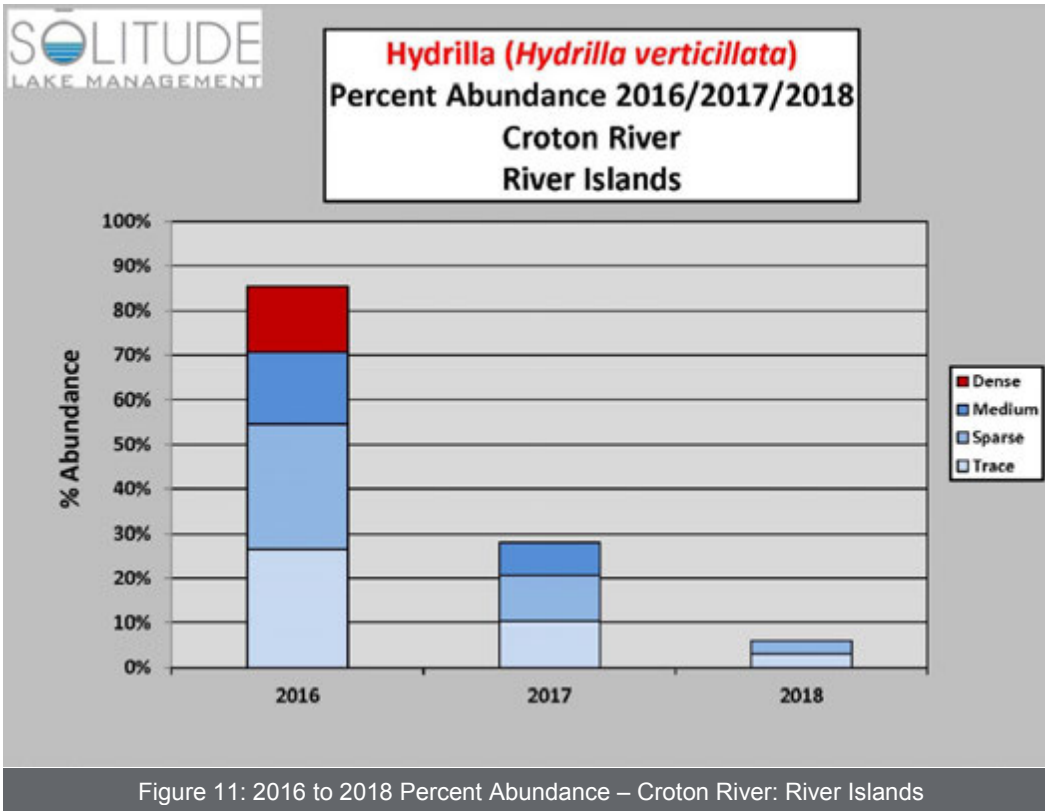
Figure 11: 2016 to 2018 Percent Abundance – Croton River: River Islands

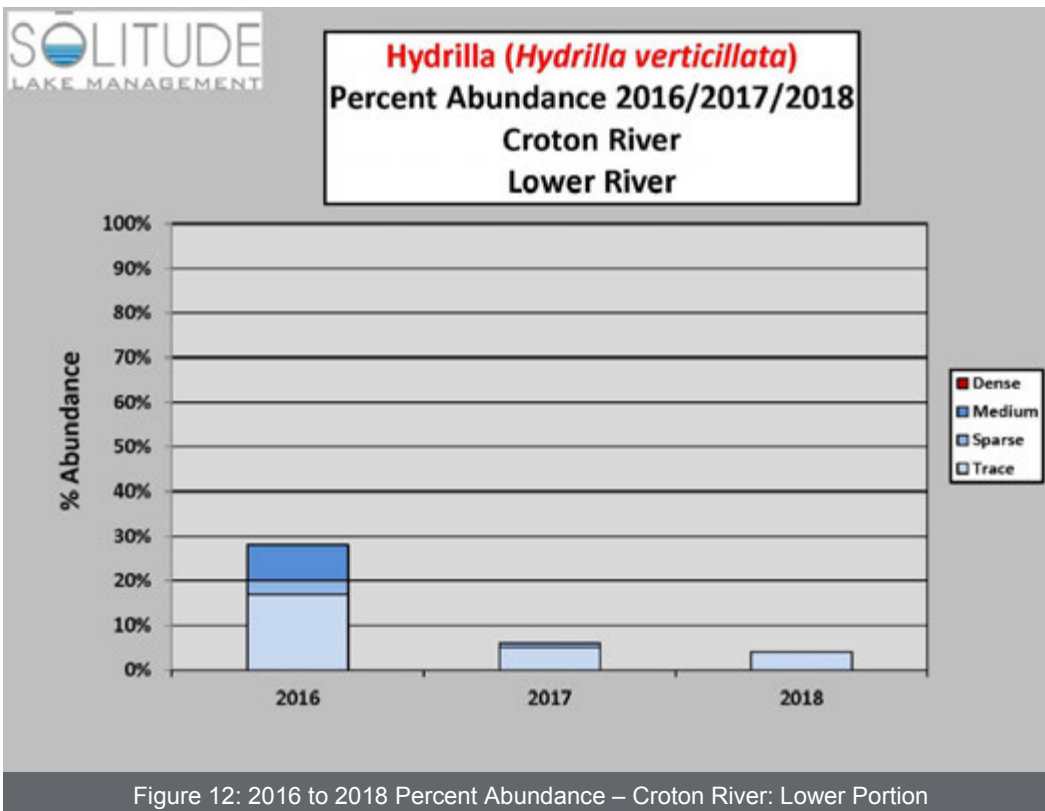
Figure 12: 2016 to 2018 Percent Abundance – Croton River: Lower Portion

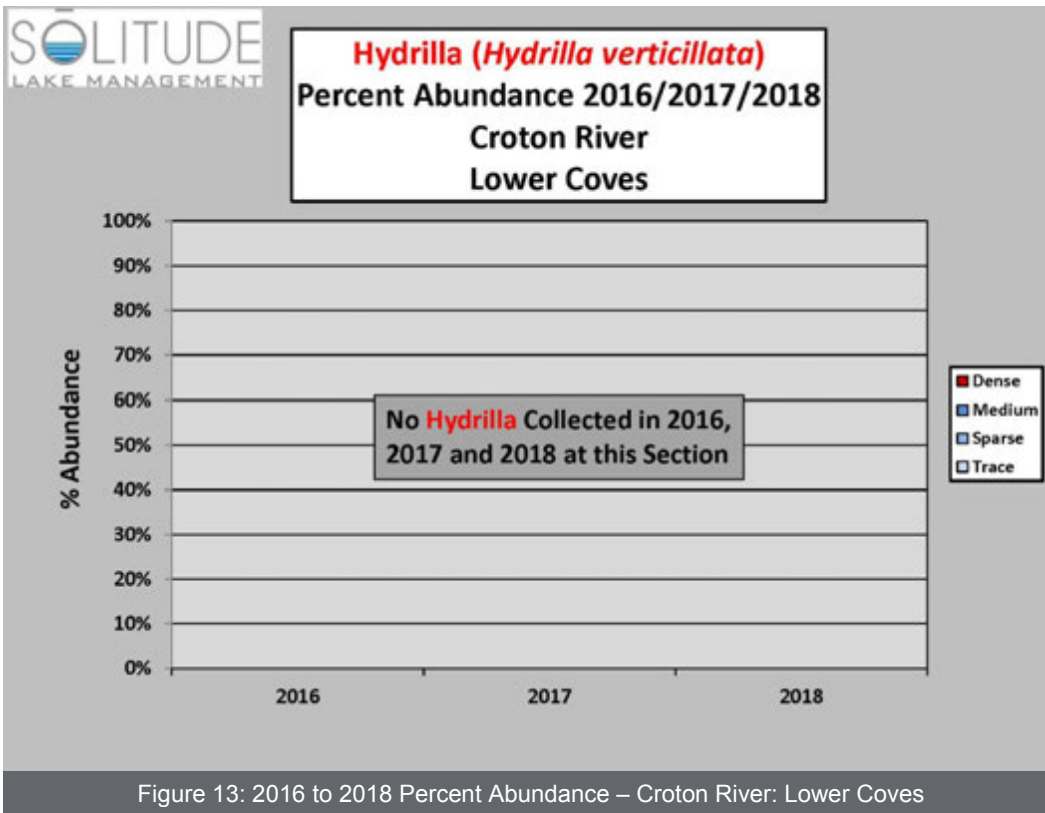
Figure 13: 2016 to 2018 Percent Abundance – Croton River: Lower Coves

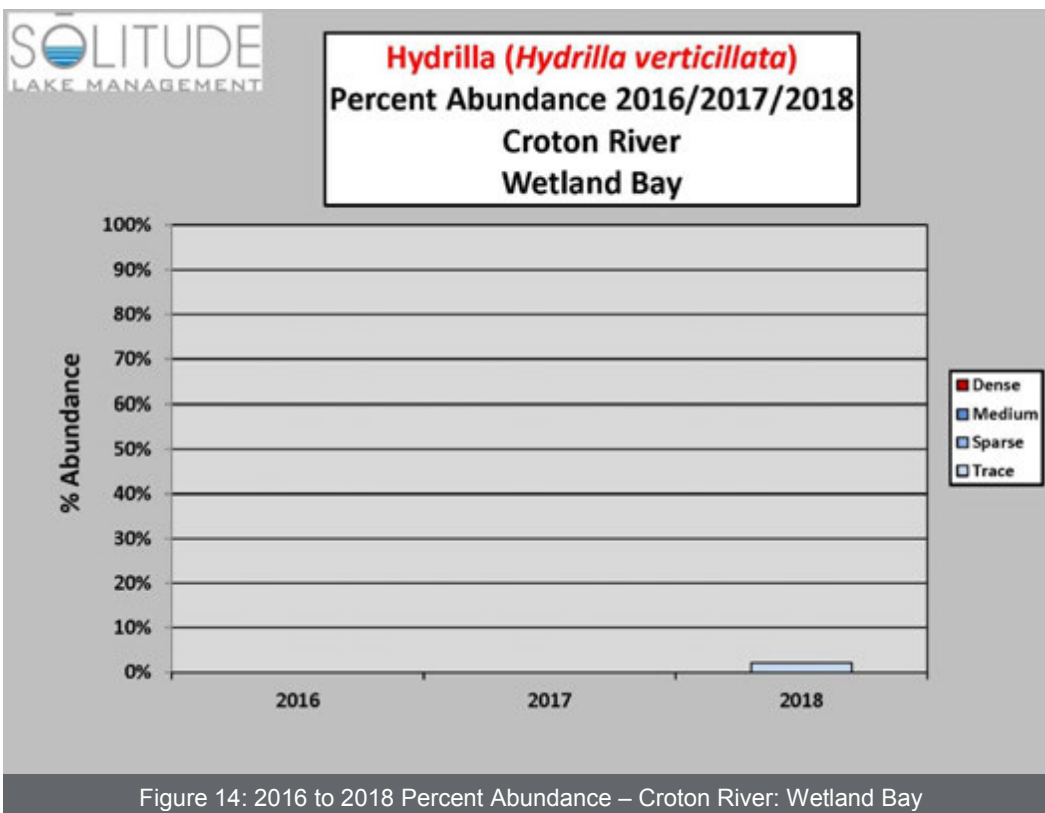
Figure 14: 2016 to 2018 Percent Abundance – Croton River: Wetland Bay

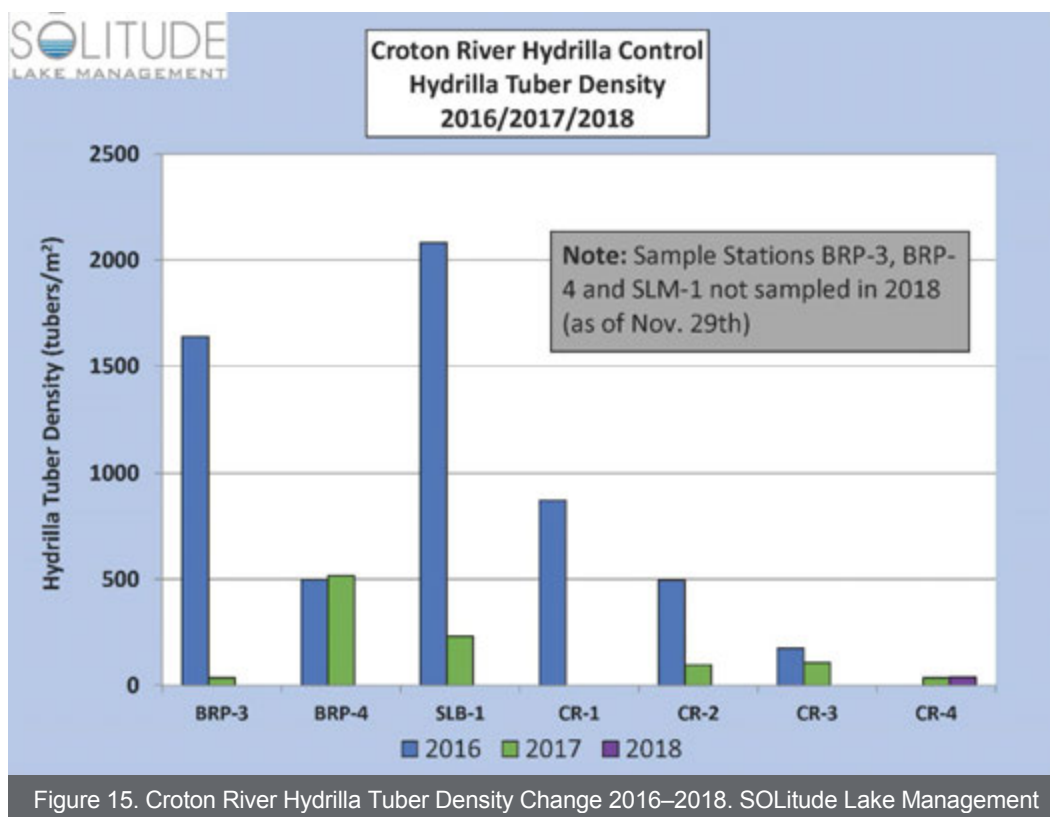
Figure 14 shows tuber density change from 2016–2018 in the Croton River. No tubers were found at CR 1, CR 2, or CR 3. The steady

decrease in tuber density is evidence that the fluridone treatment has significantly reduced the fitness of the hydrilla and that most plants were not able to form tubers during the 2017 or 2018 growing seasons. The tubers that were able to form were extremely stunted compared to untreated plants and may have had reduced or no viability due to treatment. As hydrilla abundance has been reduced via treatment, monitoring efforts have increased. In 2017, 3–6 cores were collected per site, while in 2018, 15 cores were collected per site. Hydrilla tubers can persist in the sediment and remain viable for a minimum of six years (Nawrocki 2016). Exhausting the tuber bank in order to prevent infestation is a critical part of this treatment project.

On November 13, 2018, SOLitude Lake Management conducted hydrilla tuber monitoring in the Croton River north and south of Paradise Island at four stations (CR 1, CR 2, CR 3, CR 4). Tubers were collected via airboat using a modified post-hole digger. Tuber density was calculated and expressed in tubers/m² (meters squared). Due to high flow conditions, tuber sites were not accessible at Black Rock Park (two stations: BRP 3, BRP 4) or Silver Lake Beach (one station: SLB-1). SOLitude biologists plan to sample these three remaining sites during the spring of 2019.
