## PROJECT STATUS UPDATE: 2020 CROTON HYDRILLA CONTROL PROJECT

**REPORT DATE: 06/22/20-07/03/20**

Prepared by: Nicole White, NYSDEC Invasive Species Coordination Section

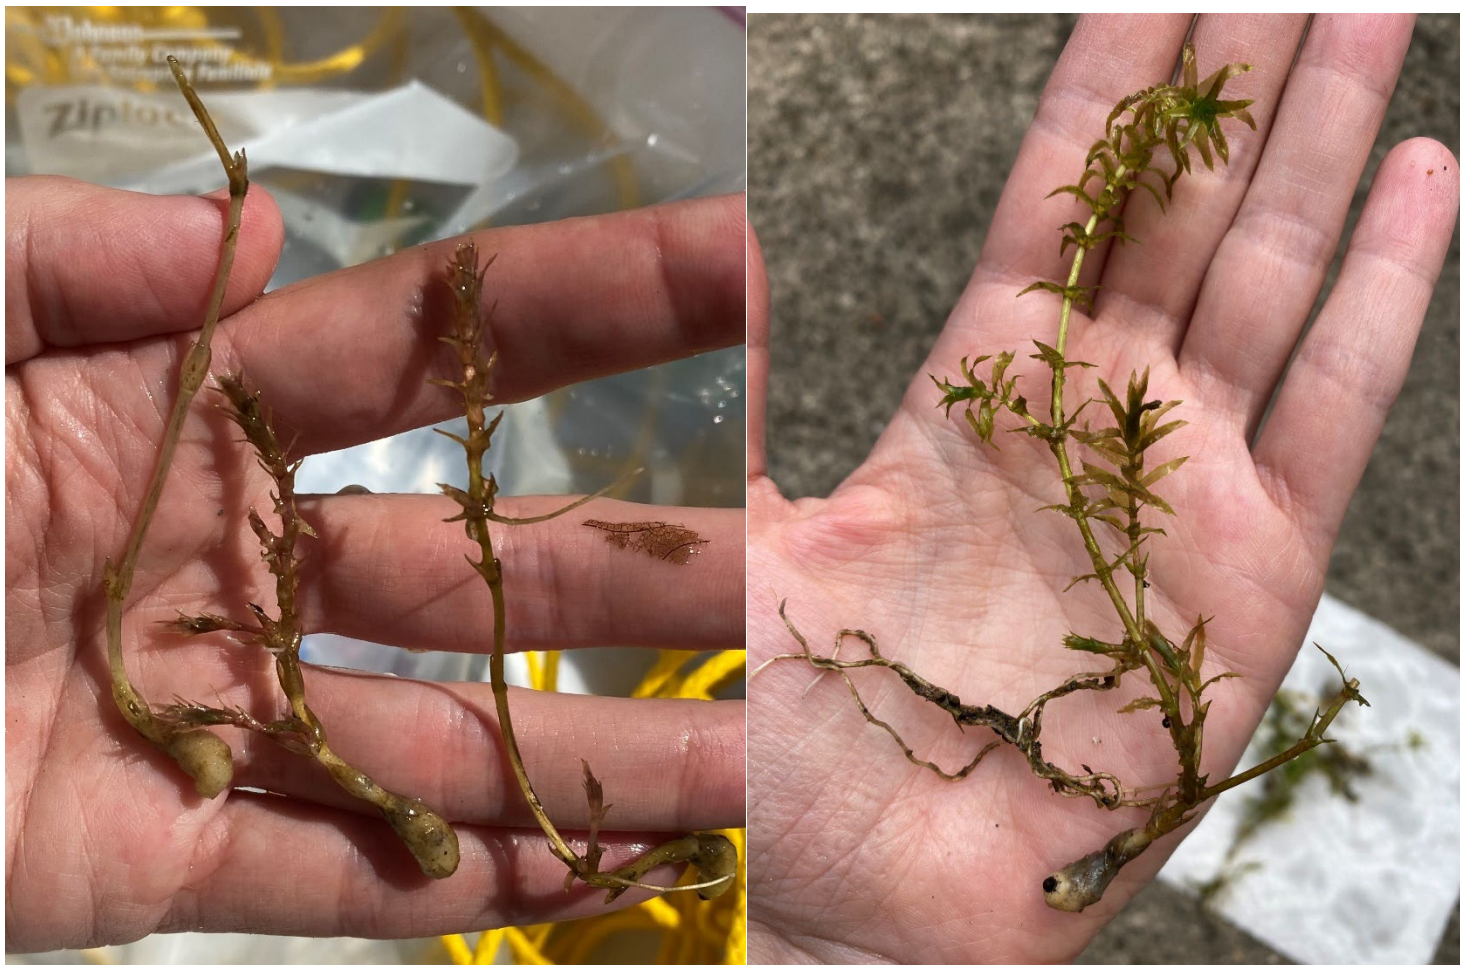
**LEFT:** *Hydrilla* germination @ CR-4 (lower river) 3 weeks after fluridone treatment began

**RIGHT:** healthy *Hydrilla* germination from untreated section of New Croton Reservoir

- Injection Units inspected by DEC ISCS: 6/22, 6/24, 6/26, 6/29, 7/1, 7/3
- Injection tanks filled by SOLitude certified applicator: 6/22, 6/29, 7/2
- In-river visual surveys for hydrilla @ BRP 6/24, 7/1 (no hydrilla found)
- In-river visual surveys for hydrilla @ CR-4 (Lower River) 6/25 – germination confirmed (see attached photos)
