## PROJECT STATUS UPDATE: 2018 CROTON HYDRILLA CONTROL PROJECT

REPORT DATE: 08/13/2018-08/24/2018

Prepared by: Nicole White, NYSDEC Invasive Species Coordination Section

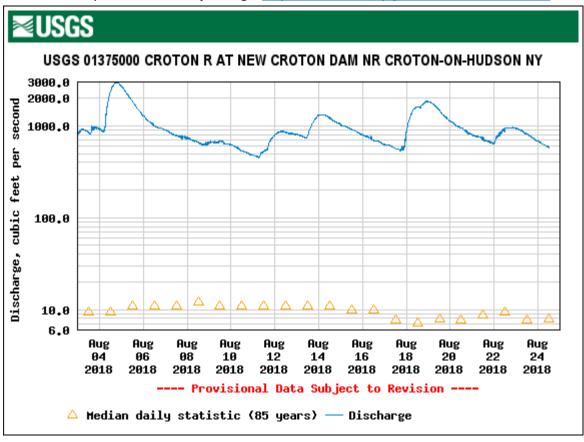
- Fluridone Treatment SHUT DOWN 8/11-8/24 due to sustained rain events and high rate of discharge in Croton River.
  - o Treatment can continue in flows up to 500 cfs. See USGS discharge graph on next page for flow info.
