**REPORT DATE: 07/22/22**

**This is the 6<sup>th</sup> year of Croton River hydrilla treatment based on DEC's adaptive management plan.** Control of the invasive aquatic plant *Hydrilla verticillata* has been highly successful since treatment began in 2017. Multiple years of treatment are required for this plant species because a robust tuber bank was established prior to treatment. The 2022 treatment again involves the injection of the aquatic herbicide fluridone (Sonar Genesis®) into the river just below the New Croton Dam (NCD) and at Black Rock Park (BRP) with a target concentration of 2.0-4.0 parts per billion (ppb) for 90 days. Drinking water sample reports are posted on this DEC webpage: <https://www.dec.ny.gov/animals/110624.html>

**Tasks Completed – 2022 Field Season**

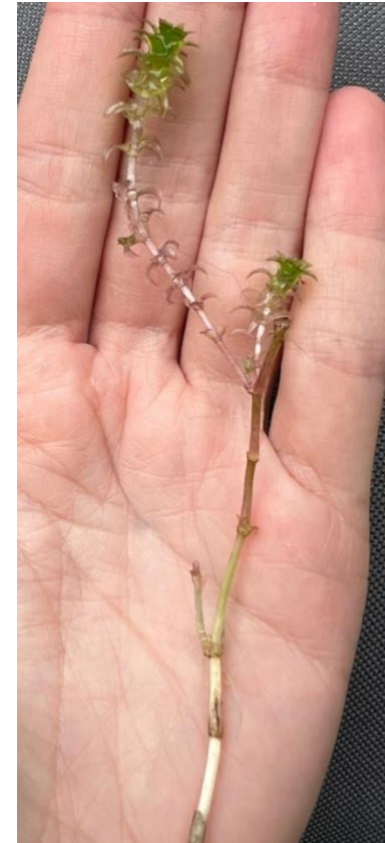
- Units inspected (DEC ISCS, SePRO, SÖLitude): 7/11, 7/15, 7/18, 7/19, 7/22
- First fluridone detection in Village wells for the season: 0.30ppb -listed as normal
- 7/19: First snorkel survey of season at Black Rock Park with LHPRISM – AIS Strike Force: 1 hydrilla plant found (see photo)
- Injection unit tanks filled by SÖLitude certified applicator: 7/15, 7/22
- Flows >500CFS caused shut down 7/19 6am-5pm
- We have reached 39 days of treatment so far in the 2022 season.

Single hydrilla plant found 7/18 @ BRP – stunted, chlorotic, and defoliated from herbicide treatment
